# Access Compliance Report

## Public Rights-of-Way

### (Curb Ramps)

Intersection ID: N/A	Main Street: YORK_CENTER	Cross Street: N/A	Location: NW
ADA ID: 29EAF73E4055	Ramp Type: Para	Initial Pass/Fail: Fail	Overall Compliance: No
		Severity Score: 12.5

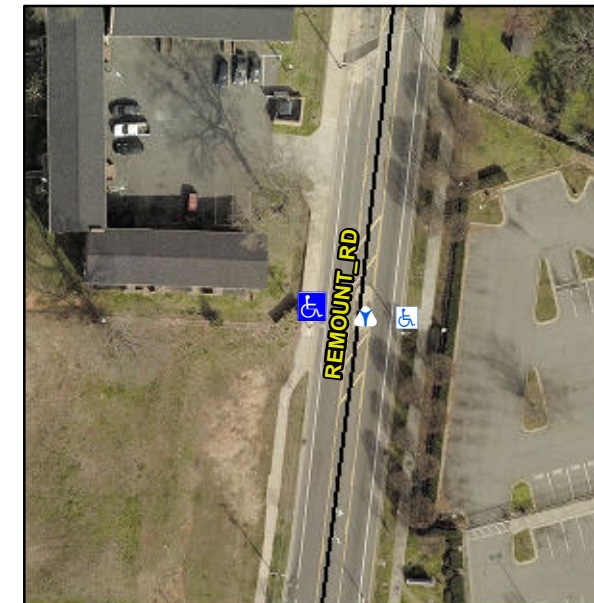
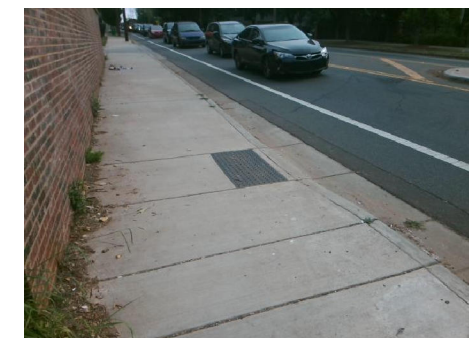
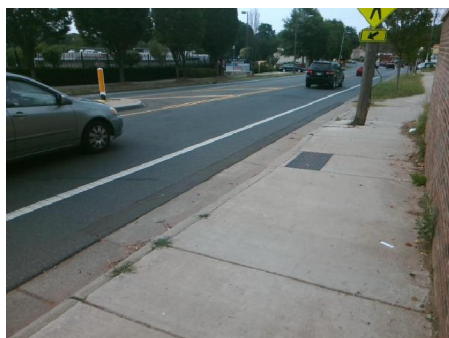
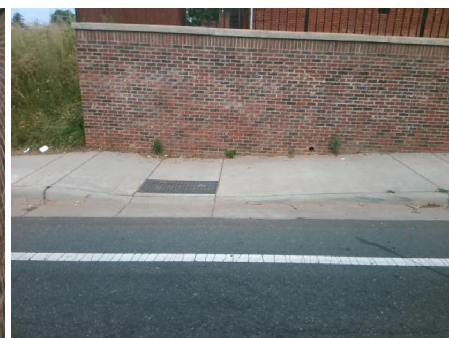
Compliance	Description	Data	Compliance	Description	Data
N/A	Ramp Length LT (in)	49.0	N/A	Ramp Length RT (in)	132.0
Yes	Ramp Width LT (in)	89.0	Yes	Ramp Width RT (in)	88.0
No	Ramp Slope LT (%)	8.7	Yes	Ramp Slope RT (%)	8.0
Yes	Ramp XSlope LT (%)	1.4	Yes	Ramp XSlope RT (%)	1.4
N/A	Landing Length (in)	N/A	N/A	DWS Provided?	N/A
N/A	Landing Width (in)	N/A	N/A	DWS Contrast?	N/A
N/A	Landing Slope (%)	N/A	N/A	DWS Length (in)	N/A
N/A	Landing X Slope (%)	N/A	N/A	DWS Full Width?	N/A
N/A	Landing Curb? (Y/N)	N/A	N/A	DWS Offset (in)	N/A
N/A	Shared Landing?	N/A			
N/A	Gutter Ponding?	N/A	N/A	Gutter Slope (%)	N/A
N/A	Gutter Lip Ht (in)	N/A	N/A	Gutter X Slope (%)	N/A
N/A	Painted X Walk1?	No	N/A	Painted X Walk2?	N/A
	X Walk 1 Direction	To E		X Walk 2 Direction	N/A
N/A	X Walk 1 Width (in)	N/A	N/A	X Walk 2 Width (in)	N/A
	X Walk 1 Slope (%)	7.3		X Walk 2 Slope (%)	N/A
	X Walk 1 X Slope (%)	3.5		X Walk 2 X Slope (%)	N/A
N/A	Ramp inside XWalk1?	N/A	N/A	Ramp inside XWalk2?	N/A

Road Slope (%)	N/A	N/A	Clear Space?	N/A
	Road X Slope (%)	N/A	N/A	Clear Space to XWalk (in)	N/A
N/A	Any Obstructions?	N/A	N/A	Storm Grate/Utility Hazard?	N/A
	Obstruction Type			Storm Grate/Utility Type	
		N/A			N/A
			Yes	Surface Condition? (G/P)	Good
			N/A	Curb Slope (%)	6.3

**Remove & Replace Entire Ramp.**
