Access Compliance Report

Public Rights-of-Way

(Curb Ramps)

Intersection ID: 46223	Main Street: COBLE_AV	Cross Street: PARKERS_CROSSING_DR	Location: SW
ADA ID: 29EC57FCC168	Ramp Type: PerpDiag	Initial Pass/Fail: Fail	Overall Compliance: No
		Severity Score: 22.5

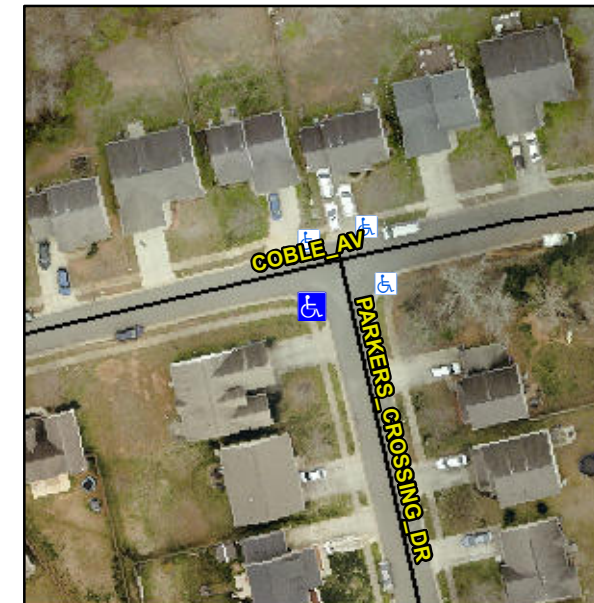
Not Found, R304.5.1, R304.2.2, R304.5.3

Compliance	Description	Data	Compliance	Description	Data
N/A	Ramp Length (in)	48.0	No	Ramp Slope (%)	9.2
No	Ramp Width (in)	38.5	No	Ramp XSlope (%)	2.5
N/A	Flare Type LT	N/A	N/A	Flare Type RT	N/A
N/A	Flare Slope LT (%)	N/A	N/A	Flare Slope RT (%)	N/A
N/A	Flare Traversable LT?	N/A	N/A	Flare Traversable RT?	N/A
N/A	Landing Length (in)	N/A	N/A	DWS Provided?	N/A
N/A	Landing Width (in)	N/A	N/A	DWS Contrast?	N/A
N/A	Landing Slope (%)	N/A	N/A	DWS Length (in)	N/A
N/A	Landing X Slope (%)	N/A	N/A	DWS Full Width?	N/A
N/A	Landing Curb? (Y/N)	N/A	N/A	DWS Offset (in)	N/A
N/A	Shared Landing?	N/A			
N/A	Gutter Ponding?	N/A	N/A	Gutter Slope (%)	N/A
N/A	Gutter Lip Ht (in)	N/A	N/A	Gutter X Slope (%)	N/A
N/A	Painted X Walk1?	No	N/A	Painted X Walk2?	No
	X Walk 1 Direction	To E		X Walk 2 Direction	To N
N/A	X Walk 1 Width (in)	N/A	N/A	X Walk 2 Width (in)	N/A
	X Walk 1 Slope (%)	1.4		X Walk 2 Slope (%)	2.0
	X Walk 1 X Slope (%)	4.1		X Walk 2 X Slope (%)	1.6

Remove & Replace Curb Ramp With Two New Directional Ramps or Equivalent.
