Access Compliance Report

Public Rights-of-Way

(Curb Ramps)

Intersection ID: 12925	Main Street: S_CHURCH_ST	Cross Street: W_CARSON_BV	Location: NW
ADA ID: 29F6AD618094	Ramp Type: Perp	Initial Pass/Fail: Fail	Overall Compliance: No
		Severity Score: 25

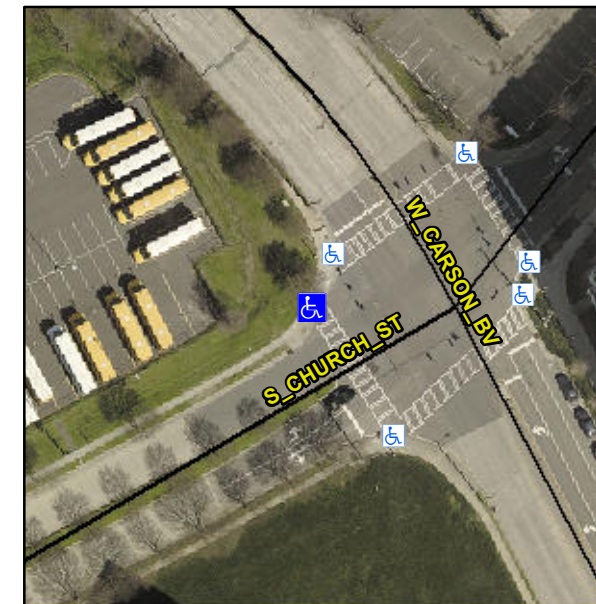
R304.5.3

Compliance	Description	Data	Compliance	Description	Data
N/A	Ramp Length (in)	95.0	Yes	Ramp Slope (%)	8.3
Yes	Ramp Width (in)	48.0	No	Ramp XSlope (%)	8.4
N/A	Flare Type LT	N/A	N/A	Flare Type RT	N/A
N/A	Flare Slope LT (%)	N/A	N/A	Flare Slope RT (%)	N/A
N/A	Flare Traversable LT?	N/A	N/A	Flare Traversable RT?	N/A
N/A	Landing Length (in)	N/A	N/A	DWS Provided?	N/A
N/A	Landing Width (in)	N/A	N/A	DWS Contrast?	N/A
N/A	Landing Slope (%)	N/A	N/A	DWS Length (in)	N/A
N/A	Landing X Slope (%)	N/A	N/A	DWS Full Width?	N/A
N/A	Landing Curb? (Y/N)	N/A	N/A	DWS Offset (in)	N/A
N/A	Shared Landing?	N/A			
N/A	Gutter Ponding?	N/A	N/A	Gutter Slope (%)	N/A
N/A	Gutter Lip Ht (in)	N/A	N/A	Gutter X Slope (%)	N/A
N/A	Painted X Walk1?	Yes	N/A	Painted X Walk2?	N/A
	X Walk 1 Direction	To SE		X Walk 2 Direction	N/A
N/A	X Walk 1 Width (in)	108.0	N/A	X Walk 2 Width (in)	N/A
	X Walk 1 Slope (%)	4.0		X Walk 2 Slope (%)	N/A
	X Walk 1 X Slope (%)	2.2		X Walk 2 X Slope (%)	N/A

N/A	Ramp inside XWalk1?	Yes	N/A	Ramp inside XWalk2?	N/A
	Road Slope (%)	N/A	N/A	Clear Space?	N/A
	Road X Slope (%)	N/A	N/A	Clear Space to XWalk (in)	N/A
N/A	Any Obstructions?	N/A	N/A	Storm Grate/Utility Hazard?	N/A
	Obstruction Type			Storm Grate/Utility Type	
		N/A			N/A
		Yes		Surface Condition? (G/P)	Good

Remove & Replace Entire Ramp.
