# Access Compliance Report

### (Curb Ramps)

| Intersection ID: 17342 | Main Street: AUTUMN_RAIN_LN | Cross Street: KIRKFIELD_CT | Location: NE |
| ADA ID: 29F9CC4300CC | Ramp Type: BlendTrans1 | Initial Pass/Fail: Fail | Overall Compliance: No |

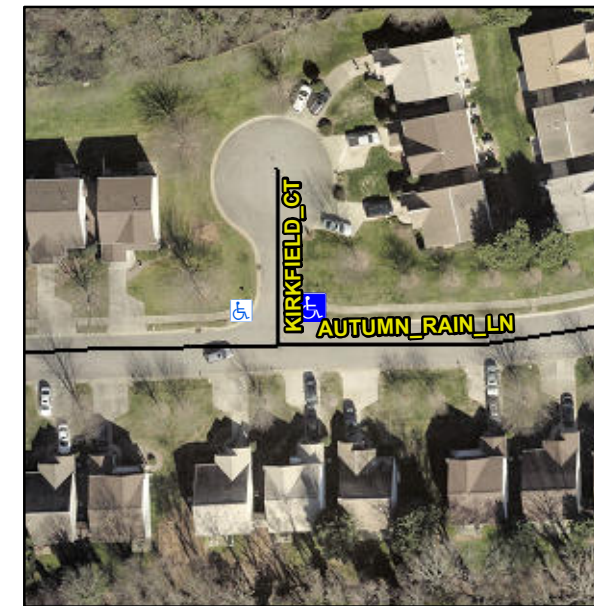
**DAMAGED RT FL**

**Not Found, R304.5.3**

| Compliance | Description | Data | Compliance | Description | Data |
|---|---|---|---|---|---|
| Yes | Ramp Width (in) | 48.0 | No | BlendTrans XSlope (%) | 5.4 |
| | | | No | Curb Slope (%) | 8.1 |

**Remove & Replace Curb Ramp With Two New Directional Ramps or Equivalent.**
