Access Compliance Report

Public Rights-of-Way

(Curb Ramps)

Intersection ID: 25709	Main Street: CHARTER_OAK_LN	Cross Street: JOHNSTON_RD	Location: SW
ADA ID: 29FDAB5DFB3E	Ramp Type: Perp	Initial Pass/Fail: Fail	Overall Compliance: No
Severity Score: 12.5			
Codes/Mitigation Info/Possible Solution		Field Measurements/Component Compliance

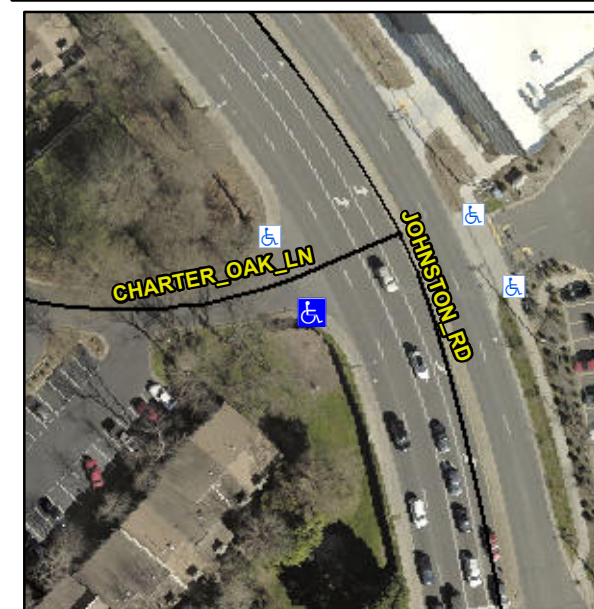
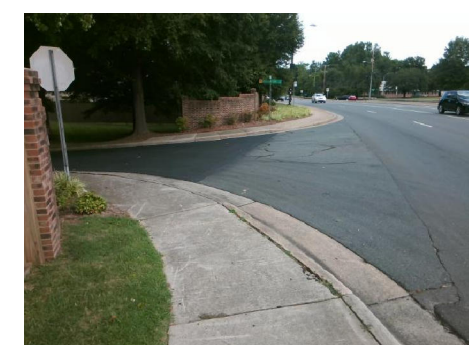
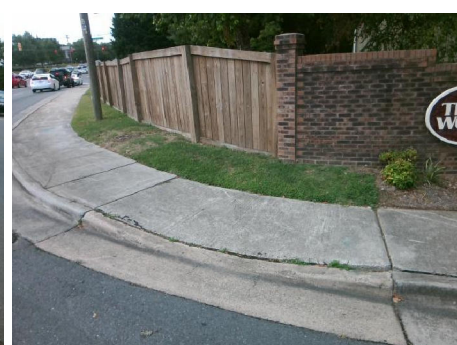
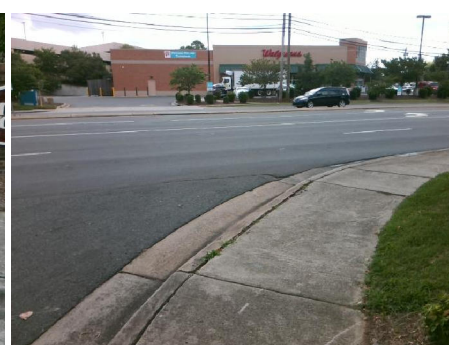
Not Found, R304.5.3

Compliance	Description	Data	Compliance	Description	Data
N/A	Ramp Length (in)	63.0	Yes	Ramp Slope (%)	5.2
Yes	Ramp Width (in)	48.0	No	Ramp XSlope (%)	6.5
N/A	Flare Type LT	N/A	N/A	Flare Type RT	N/A
N/A	Flare Slope LT (%)	N/A	N/A	Flare Slope RT (%)	N/A
N/A	Flare Traversable LT?	N/A	N/A	Flare Traversable RT?	N/A
N/A	Landing Length (in)	N/A	N/A	DWS Provided?	N/A
N/A	Landing Width (in)	N/A	N/A	DWS Contrast?	N/A
N/A	Landing Slope (%)	N/A	N/A	DWS Length (in)	N/A
N/A	Landing X Slope (%)	N/A	N/A	DWS Full Width?	N/A
N/A	Landing Curb? (Y/N)	N/A	N/A	DWS Offset (in)	N/A
N/A	Shared Landing?	N/A			
N/A	Gutter Ponding?	N/A	N/A	Gutter Slope (%)	N/A
N/A	Gutter Lip Ht (in)	N/A	N/A	Gutter X Slope (%)	N/A
N/A	Painted X Walk1?	No	N/A	Painted X Walk2?	N/A
	X Walk 1 Direction	To NW		X Walk 2 Direction	N/A
N/A	X Walk 1 Width (in)	N/A	N/A	X Walk 2 Width (in)	N/A
	X Walk 1 Slope (%)	0.1		X Walk 2 Slope (%)	N/A
	X Walk 1 X Slope (%)	5.5		X Walk 2 X Slope (%)	N/A

N/A	Ramp inside XWalk1?	N/A	N/A	Ramp inside XWalk2?	N/A
	Road Slope (%)	N/A	N/A	Clear Space?	N/A
	Road X Slope (%)	N/A	N/A	Clear Space to XWalk (in)	N/A
N/A	Any Obstructions?	N/A	N/A	Storm Grate/Utility Hazard?	N/A
	Obstruction Type			Storm Grate/Utility Type	
		N/A			N/A
		Yes		Surface Condition? (G/P)	Good

Possible Solutions:

Remove & Replace Entire Ramp.
