# Access Compliance Report

## Public Rights-of-Way

### (Curb Ramps)

Intersection ID: 53893	Main Street: PERTH_MOOR_RD	Cross Street: HAMILTON_BRIDGE_RD	Location: NE
ADA ID: 2A00CAA4898E	Ramp Type: BlendTrans1	Initial Pass/Fail: Fail	Overall Compliance: No
			Severity Score: 21.25

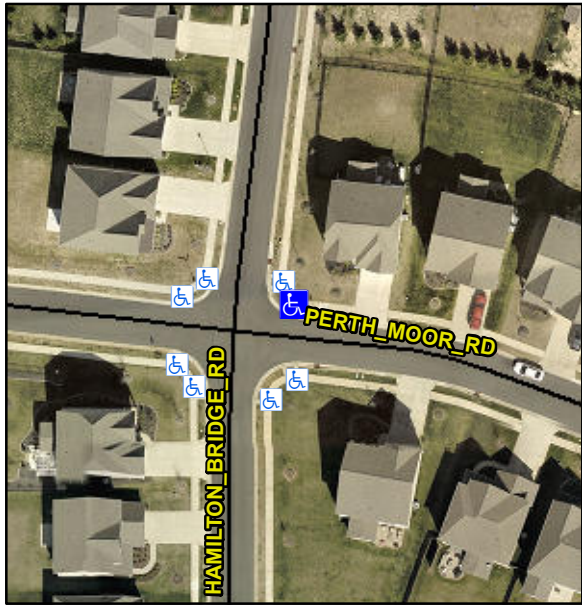
Possible Solutions:		Compliance	Description	Data	Compliance	Description	Data
	Remove & Replace Curb Ramp With Two New Directional Ramps or Equivalent.		N/A	Ramp Length (in)	46.5	Yes	BlendTrans Slope (%)	2.7
			No	Ramp Width (in)	47.0	No	BlendTrans XSlope (%)	5.2
			N/A	Flare Type LT	N/A	N/A	Flare Type RT	N/A
			N/A	Flare Slope LT (%)	N/A	N/A	Flare Slope RT (%)	N/A
			N/A	Flare Traversable LT?	N/A	N/A	Flare Traversable RT?	N/A
			N/A	Landing Length (in)	N/A	N/A	DWS Provided?	N/A
			N/A	Landing Width (in)	N/A	N/A	DWS Contrast?	N/A
			N/A	Landing Slope (%)	N/A	N/A	DWS Length (in)	N/A
			N/A	Landing X Slope (%)	N/A	N/A	DWS Full Width?	N/A
Surveyor Notes:	N/A		N/A	Landing Curb? (Y/N)	N/A	N/A	DWS Offset (in)	N/A
			N/A	Shared Landing?	N/A			
			N/A	Gutter Ponding?	N/A	N/A	Gutter Slope (%)	N/A
			N/A	Gutter Lip Ht (in)	2.0	N/A	Gutter X Slope (%)	N/A

N/A	Painted X Walk1?	No	N/A	Painted X Walk2?	N/A
				X Walk 1 Direction	To S		X Walk 2 Direction	N/A
				X Walk 1 Width (in)	N/A		X Walk 2 Width (in)	N/A
				X Walk 1 Slope (%)	2.3		X Walk 2 Slope (%)	N/A
				X Walk 1 X Slope (%)	5.6		X Walk 2 X Slope (%)	N/A
			N/A	Ramp inside XWalk1?	N/A	N/A	Ramp inside XWalk2?	N/A
PROW/ADA:	Not Found, R304.5.1, R304.5.3			Road Slope (%)	5.6		Clear Space?	N/A
				Road X Slope (%)	2.3	N/A	Clear Space to XWalk (in)	N/A
			N/A	Any Obstructions?	N/A	N/A	Storm Grate/Utility Hazard?	N/A
				Obstruction Type			Storm Grate/Utility Type	
					N/A			N/A
						Yes	Surface Condition? (G/P)	Good
						No	Curb Slope (%)	10.9
Total Cost:		\$	3200.00
