# Access Compliance Report

## Public Rights-of-Way

### (Curb Ramps)

Intersection ID: 22520	Main Street: MAGNOLIA_BRIDGE_RD	Cross Street: RIESMAN_LN	Location: E
ADA ID: 2A0B0FC53B23	Ramp Type: PerpDiag	Initial Pass/Fail: Fail	Overall Compliance: No
Severity Score: 25			
Codes/Mitigation Info/Possible Solution		Field Measurements/Component Compliance

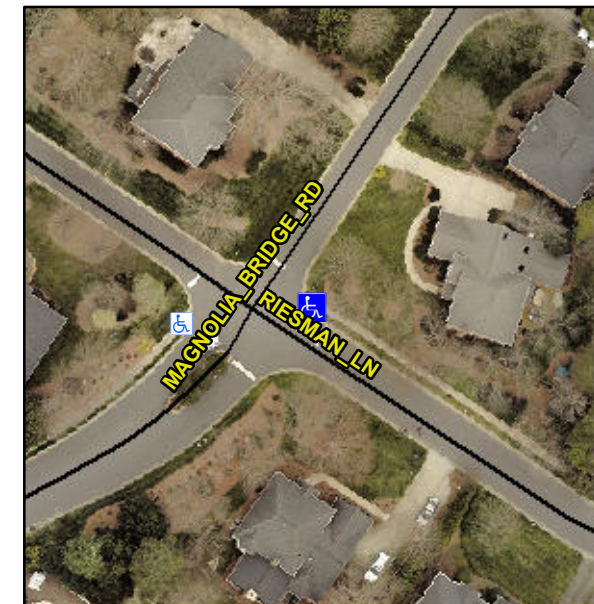
**Not Found, R304.2.2, R304.5.3**

Compliance	Description	Data	Compliance	Description	Data
N/A	Ramp Length (in)	72.0	No	Ramp Slope (%)	9.1
Yes	Ramp Width (in)	48.0	No	Ramp XSlope (%)	5.1
N/A	Flare Type LT	N/A	N/A	Flare Type RT	N/A
N/A	Flare Slope LT (%)	N/A	N/A	Flare Slope RT (%)	N/A
N/A	Flare Traversable LT?	N/A	N/A	Flare Traversable RT?	N/A
N/A	Landing Length (in)	N/A	N/A	DWS Provided?	N/A
N/A	Landing Width (in)	N/A	N/A	DWS Contrast?	N/A
N/A	Landing Slope (%)	N/A	N/A	DWS Length (in)	N/A
N/A	Landing X Slope (%)	N/A	N/A	DWS Full Width?	N/A
N/A	Landing Curb? (Y/N)	N/A	N/A	DWS Offset (in)	N/A
N/A	Shared Landing?	N/A			
N/A	Gutter Ponding?	N/A	N/A	Gutter Slope (%)	N/A
N/A	Gutter Lip Ht (in)	N/A	N/A	Gutter X Slope (%)	N/A
N/A	Painted X Walk1?	No	N/A	Painted X Walk2?	No
	X Walk 1 Direction	To NW		X Walk 2 Direction	To SW
N/A	X Walk 1 Width (in)	N/A	N/A	X Walk 2 Width (in)	N/A
	X Walk 1 Slope (%)	2.6		X Walk 2 Slope (%)	1.4
	X Walk 1 X Slope (%)	2.2		X Walk 2 X Slope (%)	6.0

N/A	Ramp inside XWalk1?	N/A	N/A	Ramp inside XWalk2?	N/A
	Road Slope (%)	5.0	N/A	Clear Space?	N/A
	Road X Slope (%)	2.7	N/A	Clear Space to XWalk (in)	N/A
N/A	Any Obstructions?	N/A	N/A	Storm Grate/Utility Hazard?	N/A
	Obstruction Type			Storm Grate/Utility Type	
		N/A			N/A
			Yes	Surface Condition? (G/P)	Good

**Remove & Replace Curb Ramp With Two New Directional Ramps or Equivalent.**

Total Cost: \$ 3200.00
