Access Compliance Report Public Rights-of-Way (Curb Ramps)

Intersection ID: 49927 Main Street: ASHBOURNE_HALL_RD Cross Street: CAMPBELL_HALL_CT Location: NE **Severity Score:** ADA ID: 2A30CA0557D4 Ramp Type: Perp Initial Pass/Fail: Fail **Overall Compliance: No** 1.25

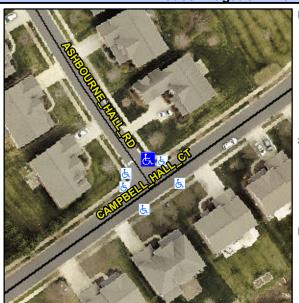
Field Measurements/Component Compliance							
Comp	liance Description	Data	Comp	liance	Description	Data	
N/A	Ramp Length (in)	49.0	Yes	Ramp	Slope (%)	8.2	
Yes	Ramp Width (in)	48.0	No	Ramp	XSlope (%)	2.9	
N/A	Flare Type LT	N/A	N/A	Flare	Type RT	N/A	
N/A	Flare Slope LT (%)	N/A	N/A	Flare	Slope RT (%)	N/A	
N/A	Flare Traversable LT?	N/A	N/A	Flare	Traversable RT?	N/A	
N/A	Landing Length (in)	N/A	N/A	DWS	Provided?	N/A	
N/A	Landing Width (in)	N/A	N/A	DWS	Contrast?	N/A	
N/A	Landing Slope (%)	N/A	N/A	DWS	Length (in)	N/A	
N/A	Landing X Slope (%)	N/A	N/A	DWS	Full Width?	N/A	
N/A	Landing Curb? (Y/N)	N/A	N/A	DWS	Offset (in)	N/A	
N/A	Shared Landing?	N/A					
N/A	Gutter Ponding?	N/A	N/A	Gutte	r Slope (%)	N/A	
N/A	Gutter Lip Ht (in)	N/A	N/A	Gutte	r X Slope (%)	N/A	
N/A	Painted X Walk1?	No	N/A	Paint	ed X Walk2?	N/A	
	X Walk 1 Direction	To SW		X Wa	lk 2 Direction	N/A	
N/A	X Walk 1 Width (in)	N/A	N/A	X Wa	lk 2 Width (in)	N/A

X Walk 1 Slope (%)	2.9		X Wa	lk 2 Slope (%)	N/A	
	X Walk 1 X Slope (%)	3.0		X Wa	lk 2 X Slope (%)	N/A	
N/A	Ramp inside XWalk1?	N/A	N/A	Ramp	inside XWalk2?	N/A	
	Road Slope (%)	N/A	N/A	Clear	Space?	N/A	
	Road X Slope (%)	N/A	N/A	Clear	Space to XWalk (in)	N/A	
N/A	Any Obstructions?	N/A	N/A	Storm	n Grate/Utility Hazard?	N/A	
	Obstruction Type			Storm	n Grate/Utility Type		
		N/A				N/A	
			Yes	Surfa	ce Condition? (G/P)	Good

71 CSSIBIC COIGUION	
Possible Solutions:	<u>c</u>
Remove & Replace Entire Ramp.	N
	Ye
	N/
ļ	N.
	N
	N
Surveyor Notes:	N
N/A	N
	N
	N
	N
PROW/ADA:	N
Not Found, R304.5.3	N
· ·	N
	N
