Access Compliance Report Public Rights-of-Way (Curb Ramps)

Intersection ID: 11490 Main Street: GRACE_ST **Cross Street: PARSON_ST** Location: NW **Overall Compliance: No** ADA ID: 2A37A46F3D84 Ramp Type: Perp Initial Pass/Fail: Fail **Severity Score:** 12.5

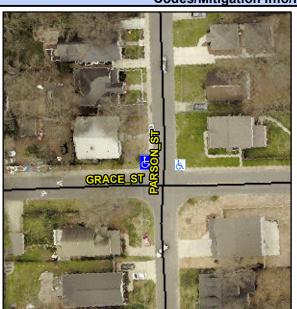
Field Measurements/Component Compliance						
Comp	liance Description	Data	Comp	liance Description	Data	
N/A	Ramp Length (in)	52.0	No	Ramp Slope (%)	10.9	
Yes	Ramp Width (in)	58.0	Yes	Ramp XSlope (%)	1.3	
N/A	Flare Type LT	N/A	N/A	Flare Type RT	N/A	
N/A	Flare Slope LT (%)	N/A	N/A	Flare Slope RT (%)	N/A	
N/A	Flare Traversable LT?	N/A	N/A	Flare Traversable RT?	N/A	
N/A	Landing Length (in)	N/A	N/A	DWS Provided?	N/A	
N/A	Landing Width (in)	N/A	N/A	DWS Contrast?	N/A	
N/A	Landing Slope (%)	N/A	N/A	DWS Length (in)	N/A	
N/A	Landing X Slope (%)	N/A	N/A	DWS Full Width?	N/A	
N/A	Landing Curb? (Y/N)	N/A	N/A	DWS Offset (in)	N/A	
N/A	Shared Landing?	N/A				
N/A	Gutter Ponding?	N/A	N/A	Gutter Slope (%)	N/A	
N/A	Gutter Lip Ht (in)	1.5	N/A	Gutter X Slope (%)	N/A	
N/A	Painted X Walk1?	No	N/A	Painted X Walk2?	N/A	
	X Walk 1 Direction	To E		X Walk 2 Direction	N/A	
N/A	X Walk 1 Width (in)	N/A	N/A	X Walk 2 Width (in)	N/A	
	X Walk 1 Slope (%)	5.8		X Walk 2 Slope (%)	N/A

Pussible solution	
Possible Solutions:	Com
Remove & Replace Entire Ramp.	N/A
	Yes
	N/A
	N/A
	N/A
	N/A
Surveyor Notes:	N/A
N/A	N/A
	N/A
	N/A
	N/A
PROW/ADA:	N/A
Not Found, R304.2.2	N/A
	N/A
	N/A
	N/A
