Access Compliance Report

Public Rights-of-Way

(Curb Ramps)

Intersection ID: 9526	Main Street: DELTA LAKE DR	Cross Street: DELTA LN	Location: NE
ADA ID: 2A49144A34AA	Ramp Type: Para	Initial Pass/Fail: Fail	Overall Compliance: No
		Severity Score: 12.5

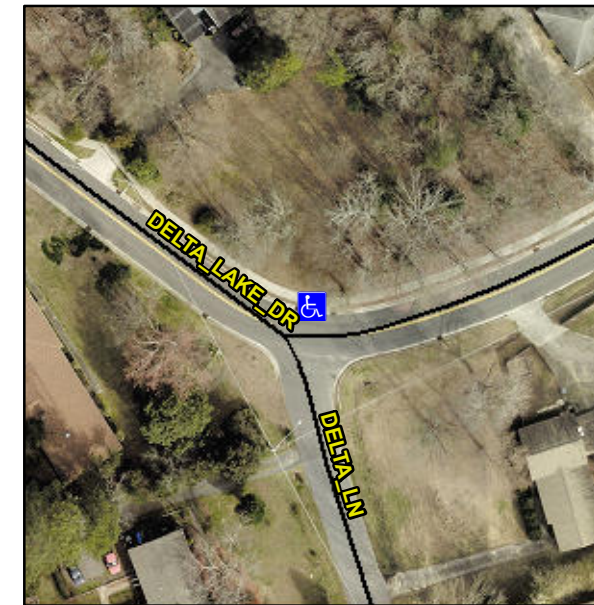
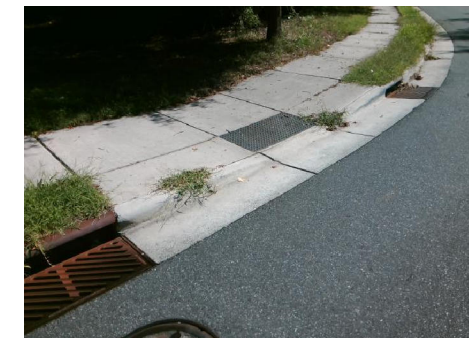
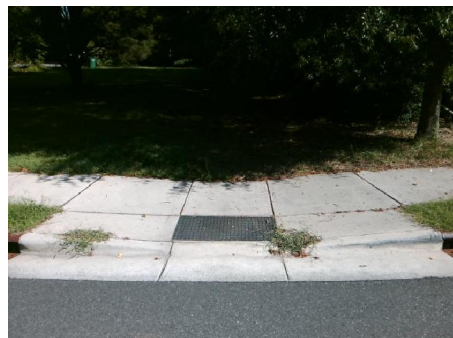
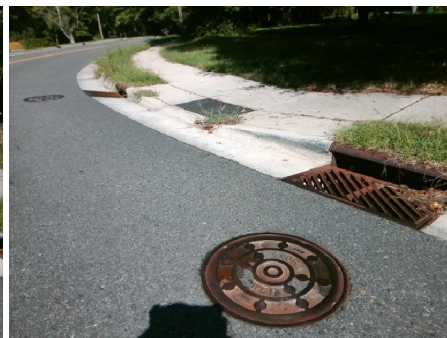
LT RP < 5%

Compliance	Description	Data	Compliance	Description	Data
N/A	Ramp Length LT (in)	59.5	N/A	Ramp Length RT (in)	57.5
Yes	Ramp Width LT (in)	59.5	Yes	Ramp Width RT (in)	61.0
Yes	Ramp Slope LT (%)	1.8	No	Ramp Slope RT (%)	10.3
Yes	Ramp XSlope LT (%)	1.2	Yes	Ramp XSlope RT (%)	1.8
N/A	Landing Length (in)	N/A	N/A	DWS Provided?	N/A
N/A	Landing Width (in)	N/A	N/A	DWS Contrast?	N/A
N/A	Landing Slope (%)	N/A	N/A	DWS Length (in)	N/A
N/A	Landing X Slope (%)	N/A	N/A	DWS Full Width?	N/A
N/A	Landing Curb? (Y/N)	N/A	N/A	DWS Offset (in)	N/A
N/A	Shared Landing?	N/A			
N/A	Gutter Ponding?	N/A	N/A	Gutter Slope (%)	N/A
N/A	Gutter Lip Ht (in)	N/A	N/A	Gutter X Slope (%)	N/A
N/A	Painted X Walk1?	No	N/A	Painted X Walk2?	N/A
	X Walk 1 Direction	To S		X Walk 2 Direction	N/A
N/A	X Walk 1 Width (in)	N/A	N/A	X Walk 2 Width (in)	N/A
	X Walk 1 Slope (%)	0.3		X Walk 2 Slope (%)	N/A
	X Walk 1 X Slope (%)	2.3		X Walk 2 X Slope (%)	N/A
N/A	Ramp inside XWalk1?	N/A	N/A	Ramp inside XWalk2?	N/A

Road Slope (%)	N/A	N/A	Clear Space?	N/A
	Road X Slope (%)	N/A	N/A	Clear Space to XWalk (in)	N/A
N/A	Any Obstructions?	N/A	N/A	Storm Grate/Utility Hazard?	N/A
	Obstruction Type			Storm Grate/Utility Type	
		N/A			N/A
			Yes	Surface Condition? (G/P)	Good
			N/A	Curb Slope (%)	17.6

Remove & Replace Entire Ramp.

R304.3.2

\$ 1600.00
