Intersection ID: 23411	Main Street: DULVERTON_DR	Cross Street: LANCER_DR	Location:	W
ADA ID: 2A4B49A7490E	Ramp Type: PerpDiag	Initial Pass/Fail: Fail	Overall Compliance: No	Severity Score: 8.75

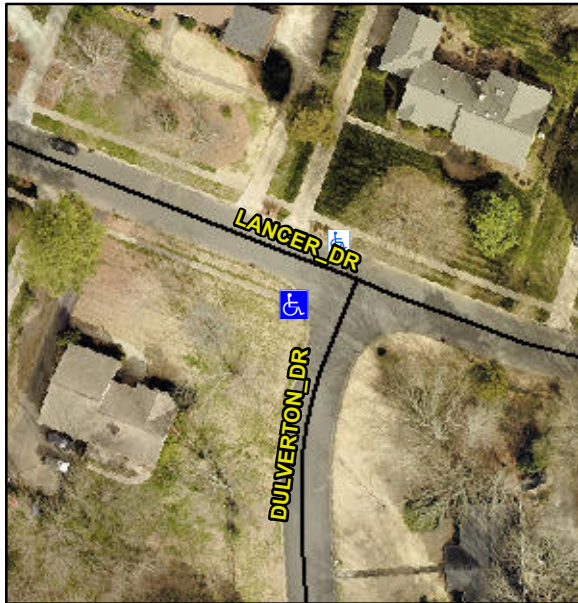
Not Found, R304.5.1

Compliance	Description	Data	Compliance	Description	Data
N/A	Ramp Length (in)	60.0	Yes	Ramp Slope (%)	7.0
No	Ramp Width (in)	40.0	Yes	Ramp XSlope (%)	0.5
N/A	Flare Type LT	N/A	N/A	Flare Type RT	N/A
N/A	Flare Slope LT (%)	N/A	N/A	Flare Slope RT (%)	N/A
N/A	Flare Traversable LT?	N/A	N/A	Flare Traversable RT?	N/A
N/A	Landing Length (in)	N/A	N/A	DWS Provided?	N/A
N/A	Landing Width (in)	N/A	N/A	DWS Contrast?	N/A
N/A	Landing Slope (%)	N/A	N/A	DWS Length (in)	N/A
N/A	Landing X Slope (%)	N/A	N/A	DWS Full Width?	N/A
N/A	Landing Curb? (Y/N)	N/A	N/A	DWS Offset (in)	N/A
N/A	Shared Landing?	N/A			
N/A	Gutter Ponding?	N/A	N/A	Gutter Slope (%)	N/A
N/A	Gutter Lip Ht (in)	N/A	N/A	Gutter X Slope (%)	N/A
N/A	Painted X Walk1?	No	N/A	Painted X Walk2?	No
	X Walk 1 Direction	To SE		X Walk 2 Direction	To NE
N/A	X Walk 1 Width (in)	N/A	N/A	X Walk 2 Width (in)	N/A
	X Walk 1 Slope (%)	2.1		X Walk 2 Slope (%)	0.9
	X Walk 1 X Slope (%)	0.9		X Walk 2 X Slope (%)	1.3

N/A	Ramp inside XWalk1?	N/A	N/A	Ramp inside XWalk2?	N/A
	Road Slope (%)	1.8	N/A	Clear Space?	N/A
	Road X Slope (%)	0.2	N/A	Clear Space to XWalk (in)	N/A
N/A	Any Obstructions?	N/A	N/A	Storm Grate/Utility Hazard?	N/A
	Obstruction Type			Storm Grate/Utility Type	
		N/A			N/A
			Yes	Surface Condition? (G/P)	Good

Remove & Replace Curb Ramp With Two New Directional Ramps or Equivalent.
