# Access Compliance Report

## Public Rights-of-Way

### (Curb Ramps)

Intersection ID: N/A	Main Street: WINDY RIDGE RD	Cross Street: HUMBERVIEW_LN	Location: E
ADA ID: 2A4C7B95BB08	Ramp Type: Perp	Initial Pass/Fail: Fail	Overall Compliance: No
Severity Score: 21.25			
Codes/Mitigation Info/Possible Solution		Field Measurements/Component Compliance

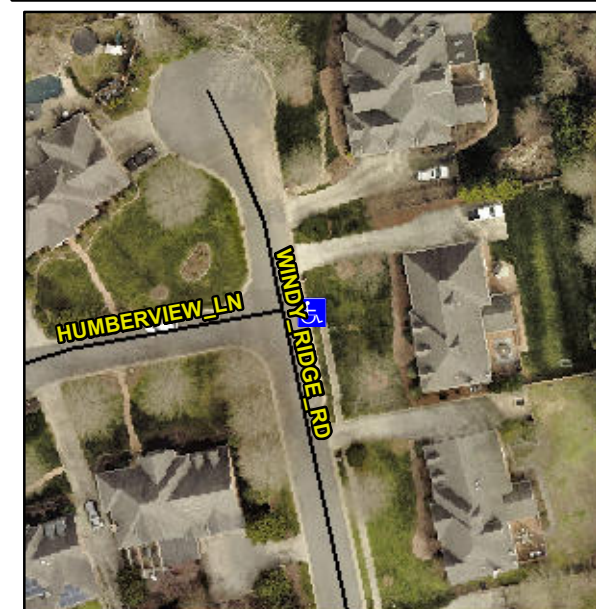
**Not Found, R304.5.1, R304.2.2**

Compliance	Description	Data	Compliance	Description	Data
N/A	Ramp Length (in)	47.5	No	Ramp Slope (%)	8.7
No	Ramp Width (in)	44.0	Yes	Ramp XSlope (%)	1.4
N/A	Flare Type LT	N/A	N/A	Flare Type RT	N/A
N/A	Flare Slope LT (%)	N/A	N/A	Flare Slope RT (%)	N/A
N/A	Flare Traversable LT?	N/A	N/A	Flare Traversable RT?	N/A
N/A	Landing Length (in)	N/A	N/A	DWS Provided?	N/A
N/A	Landing Width (in)	N/A	N/A	DWS Contrast?	N/A
N/A	Landing Slope (%)	N/A	N/A	DWS Length (in)	N/A
N/A	Landing X Slope (%)	N/A	N/A	DWS Full Width?	N/A
N/A	Landing Curb? (Y/N)	N/A	N/A	DWS Offset (in)	N/A
N/A	Shared Landing?	N/A			
N/A	Gutter Ponding?	N/A	N/A	Gutter Slope (%)	N/A
N/A	Gutter Lip Ht (in)	N/A	N/A	Gutter X Slope (%)	N/A
N/A	Painted X Walk1?	No	N/A	Painted X Walk2?	N/A
	X Walk 1 Direction	To W		X Walk 2 Direction	N/A
N/A	X Walk 1 Width (in)	N/A	N/A	X Walk 2 Width (in)	N/A
	X Walk 1 Slope (%)	1.7		X Walk 2 Slope (%)	N/A
	X Walk 1 X Slope (%)	1.2		X Walk 2 X Slope (%)	N/A

N/A	Ramp inside XWalk1?	N/A	N/A	Ramp inside XWalk2?	N/A
	Road Slope (%)	N/A	N/A	Clear Space?	N/A
	Road X Slope (%)	N/A	N/A	Clear Space to XWalk (in)	N/A
N/A	Any Obstructions?	N/A	N/A	Storm Grate/Utility Hazard?	N/A
	Obstruction Type			Storm Grate/Utility Type	
		N/A			N/A
			Yes	Surface Condition? (G/P)	Good

Possible Solutions:

**Remove & Replace Entire Ramp.**

Total Cost: \$ 1850.00
