# Access Compliance Report

## Public Rights-of-Way

### (Curb Ramps)

Intersection ID: 45777	Main Street: SUGARBUSH_DR	Cross Street: CARVER_FALLS_RD	Location: W
ADA ID: 2A53882739C2	Ramp Type: Perp	Initial Pass/Fail: Fail	Overall Compliance: No
Severity Score: 8.75			
Codes/Mitigation Info/Possible Solution		Field Measurements/Component Compliance

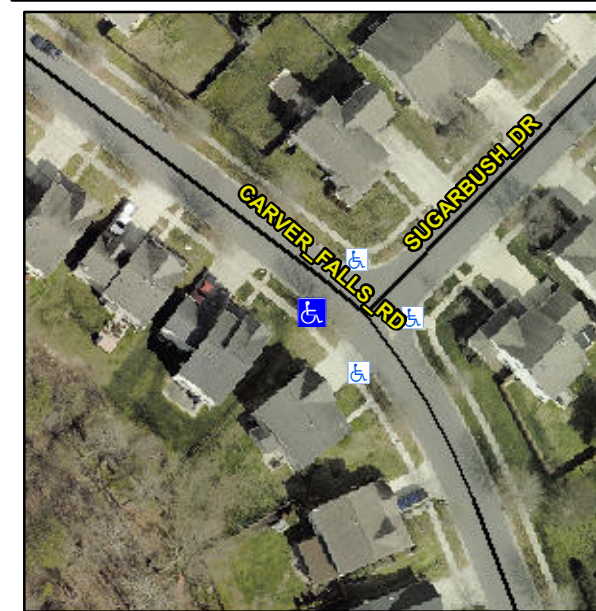
**Not Found, R304.5.1**

Compliance	Description	Data	Compliance	Description	Data
N/A	Ramp Length (in)	72.0	Yes	Ramp Slope (%)	5.0
No	Ramp Width (in)	47.5	Yes	Ramp XSlope (%)	1.6
N/A	Flare Type LT	N/A	N/A	Flare Type RT	N/A
N/A	Flare Slope LT (%)	N/A	N/A	Flare Slope RT (%)	N/A
N/A	Flare Traversable LT?	N/A	N/A	Flare Traversable RT?	N/A
N/A	Landing Length (in)	N/A	N/A	DWS Provided?	N/A
N/A	Landing Width (in)	N/A	N/A	DWS Contrast?	N/A
N/A	Landing Slope (%)	N/A	N/A	DWS Length (in)	N/A
N/A	Landing X Slope (%)	N/A	N/A	DWS Full Width?	N/A
N/A	Landing Curb? (Y/N)	N/A	N/A	DWS Offset (in)	N/A
N/A	Shared Landing?	N/A			
N/A	Gutter Ponding?	N/A	N/A	Gutter Slope (%)	N/A
N/A	Gutter Lip Ht (in)	N/A	N/A	Gutter X Slope (%)	N/A
N/A	Painted X Walk1?	No	N/A	Painted X Walk2?	N/A
	X Walk 1 Direction	To NE		X Walk 2 Direction	N/A
N/A	X Walk 1 Width (in)	N/A	N/A	X Walk 2 Width (in)	N/A
	X Walk 1 Slope (%)	3.5		X Walk 2 Slope (%)	N/A
	X Walk 1 X Slope (%)	2.1		X Walk 2 X Slope (%)	N/A

N/A	Ramp inside XWalk1?	N/A	N/A	Ramp inside XWalk2?	N/A
	Road Slope (%)	N/A	N/A	Clear Space?	N/A
	Road X Slope (%)	N/A	N/A	Clear Space to XWalk (in)	N/A
N/A	Any Obstructions?	N/A	N/A	Storm Grate/Utility Hazard?	N/A
	Obstruction Type			Storm Grate/Utility Type	
		N/A			N/A
			Yes	Surface Condition? (G/P)	Good

Possible Solutions:

**Remove & Replace Entire Ramp.**
