# Access Compliance Report

## Public Rights-of-Way

### (Curb Ramps)

Intersection ID: 48826	Main Street: DISCOVERY_LN	Cross Street: PLEASANT_GROVE_RD	Location: SW
ADA ID: 2A5638385F75	Ramp Type: Perp	Initial Pass/Fail: Fail	Overall Compliance: No
Severity Score: 10			
Codes/Mitigation Info/Possible Solution		Field Measurements/Component Compliance

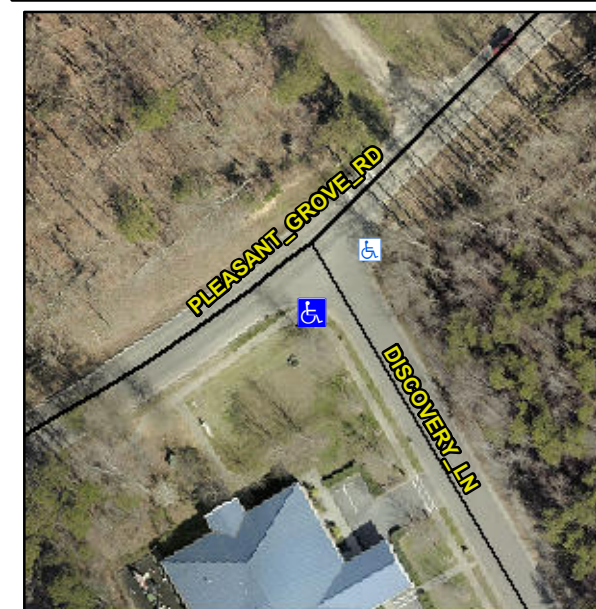
**Not Found, R304.5.1, R304.5.3**

Compliance	Description	Data	Compliance	Description	Data
N/A	Ramp Length (in)	47.0	Yes	Ramp Slope (%)	5.5
No	Ramp Width (in)	47.0	No	Ramp XSlope (%)	2.1
N/A	Flare Type LT	N/A	N/A	Flare Type RT	N/A
N/A	Flare Slope LT (%)	N/A	N/A	Flare Slope RT (%)	N/A
N/A	Flare Traversable LT?	N/A	N/A	Flare Traversable RT?	N/A
N/A	Landing Length (in)	N/A	N/A	DWS Provided?	N/A
N/A	Landing Width (in)	N/A	N/A	DWS Contrast?	N/A
N/A	Landing Slope (%)	N/A	N/A	DWS Length (in)	N/A
N/A	Landing X Slope (%)	N/A	N/A	DWS Full Width?	N/A
N/A	Landing Curb? (Y/N)	N/A	N/A	DWS Offset (in)	N/A
N/A	Shared Landing?	N/A			
N/A	Gutter Ponding?	N/A	N/A	Gutter Slope (%)	N/A
N/A	Gutter Lip Ht (in)	0.5	N/A	Gutter X Slope (%)	N/A
N/A	Painted X Walk1?	No	N/A	Painted X Walk2?	N/A
	X Walk 1 Direction	To NE		X Walk 2 Direction	N/A
N/A	X Walk 1 Width (in)	N/A	N/A	X Walk 2 Width (in)	N/A
	X Walk 1 Slope (%)	0.2		X Walk 2 Slope (%)	N/A
	X Walk 1 X Slope (%)	0.5		X Walk 2 X Slope (%)	N/A

N/A	Ramp inside XWalk1?	N/A	N/A	Ramp inside XWalk2?	N/A
	Road Slope (%)	N/A	N/A	Clear Space?	N/A
	Road X Slope (%)	N/A	N/A	Clear Space to XWalk (in)	N/A
N/A	Any Obstructions?	N/A	N/A	Storm Grate/Utility Hazard?	N/A
	Obstruction Type			Storm Grate/Utility Type	
		N/A			N/A
			Yes	Surface Condition? (G/P)	Good

**Remove & Replace Entire Ramp.**

Total Cost: \$ 1850.00
