Access Compliance Report

Public Rights-of-Way

(Curb Ramps)

Intersection ID: 15074	Main Street: MAGNOLIA_AV	Cross Street: PARK_RD	Location: SW
ADA ID: 2A69471837B0	Ramp Type: Perp	Initial Pass/Fail: Fail	Overall Compliance: No
Codes/Mitigation Info/Possible Solution		Field Measurements/Component Compliance	
Severity Score: 12.5

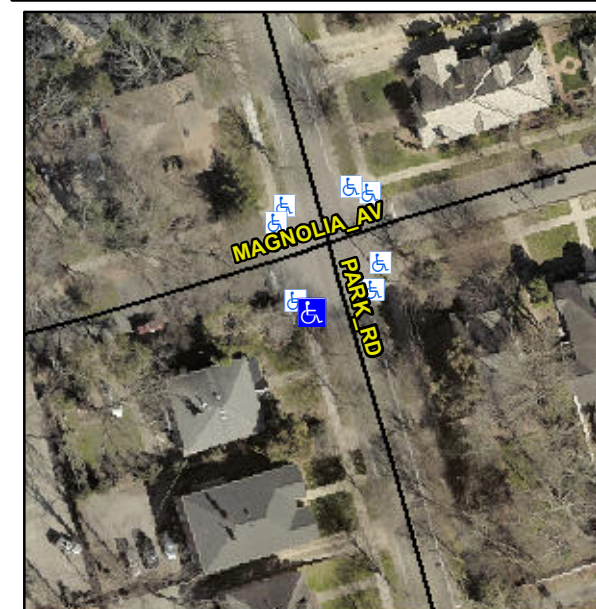
Compliance	Description	Data	Compliance	Description	Data
N/A	Ramp Length (in)	66.0	Yes	Ramp Slope (%)	5.8
Yes	Ramp Width (in)	48.0	No	Ramp XSlope (%)	5.5
N/A	Flare Type LT	N/A	N/A	Flare Type RT	N/A
N/A	Flare Slope LT (%)	N/A	N/A	Flare Slope RT (%)	N/A
N/A	Flare Traversable LT?	N/A	N/A	Flare Traversable RT?	N/A
N/A	Landing Length (in)	N/A	N/A	DWS Provided?	N/A
N/A	Landing Width (in)	N/A	N/A	DWS Contrast?	N/A
N/A	Landing Slope (%)	N/A	N/A	DWS Length (in)	N/A
N/A	Landing X Slope (%)	N/A	N/A	DWS Full Width?	N/A
N/A	Landing Curb? (Y/N)	N/A	N/A	DWS Offset (in)	N/A
N/A	Shared Landing?	N/A			
N/A	Gutter Ponding?	N/A	N/A	Gutter Slope (%)	N/A
N/A	Gutter Lip Ht (in)	1.0	N/A	Gutter X Slope (%)	N/A
N/A	Painted X Walk1?	No	N/A	Painted X Walk2?	N/A
	X Walk 1 Direction	To E		X Walk 2 Direction	N/A
N/A	X Walk 1 Width (in)	N/A	N/A	X Walk 2 Width (in)	N/A
	X Walk 1 Slope (%)	4.3		X Walk 2 Slope (%)	N/A
	X Walk 1 X Slope (%)	0.3		X Walk 2 X Slope (%)	N/A

N/A	Ramp inside XWalk1?	N/A	N/A	Ramp inside XWalk2?	N/A
	Road Slope (%)	N/A	N/A	Clear Space?	N/A
	Road X Slope (%)	N/A	N/A	Clear Space to XWalk (in)	N/A
N/A	Any Obstructions?	N/A	N/A	Storm Grate/Utility Hazard?	N/A
	Obstruction Type			Storm Grate/Utility Type	
		N/A			N/A
		Yes		Surface Condition? (G/P)	Good

Remove & Replace Entire Ramp.

R304.5.3
