Access Compliance Report

Public Rights-of-Way

(Curb Ramps)

Intersection ID: 47016	Main Street: TRIBUNE_DR	Cross Street: GLAZER_VALLEY_CT	Location: S
ADA ID: 2A6B549CB751	Ramp Type: Perp	Initial Pass/Fail: Fail	Overall Compliance: No
		Severity Score: 37.5

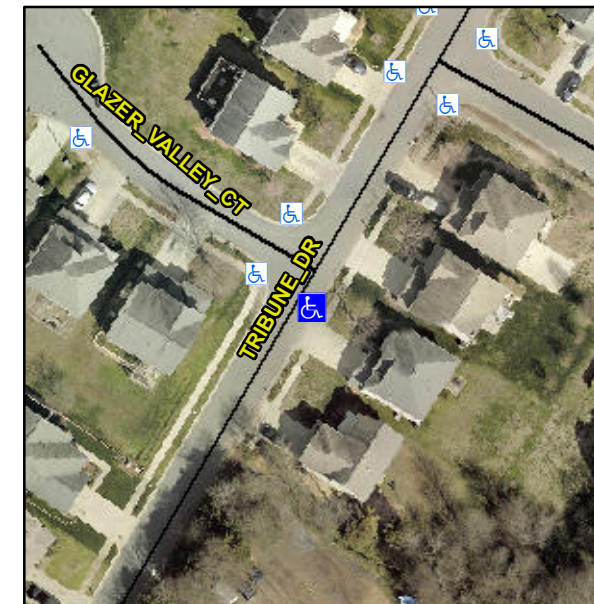
Not Found, R304.2.2, R304.5.3

Compliance	Description	Data	Compliance	Description	Data
N/A	Ramp Length (in)	48.0	No	Ramp Slope (%)	9.7
Yes	Ramp Width (in)	48.0	No	Ramp XSlope (%)	7.3
N/A	Flare Type LT	N/A	N/A	Flare Type RT	N/A
N/A	Flare Slope LT (%)	N/A	N/A	Flare Slope RT (%)	N/A
N/A	Flare Traversable LT?	N/A	N/A	Flare Traversable RT?	N/A
N/A	Landing Length (in)	N/A	N/A	DWS Provided?	N/A
N/A	Landing Width (in)	N/A	N/A	DWS Contrast?	N/A
N/A	Landing Slope (%)	N/A	N/A	DWS Length (in)	N/A
N/A	Landing X Slope (%)	N/A	N/A	DWS Full Width?	N/A
N/A	Landing Curb? (Y/N)	N/A	N/A	DWS Offset (in)	N/A
N/A	Shared Landing?	N/A			
N/A	Gutter Ponding?	N/A	N/A	Gutter Slope (%)	N/A
N/A	Gutter Lip Ht (in)	N/A	N/A	Gutter X Slope (%)	N/A
N/A	Painted X Walk1?	No	N/A	Painted X Walk2?	N/A
	X Walk 1 Direction	To NW		X Walk 2 Direction	N/A
N/A	X Walk 1 Width (in)	N/A	N/A	X Walk 2 Width (in)	N/A
	X Walk 1 Slope (%)	1.4		X Walk 2 Slope (%)	N/A
	X Walk 1 X Slope (%)	6.5		X Walk 2 X Slope (%)	N/A

N/A	Ramp inside XWalk1?	N/A	N/A	Ramp inside XWalk2?	N/A
	Road Slope (%)	N/A	N/A	Clear Space?	N/A
	Road X Slope (%)	N/A	N/A	Clear Space to XWalk (in)	N/A
N/A	Any Obstructions?	N/A	N/A	Storm Grate/Utility Hazard?	N/A
	Obstruction Type			Storm Grate/Utility Type	
		N/A			N/A
			Yes	Surface Condition? (G/P)	Good

Possible Solutions:

Remove & Replace Entire Ramp.
