Access Compliance Report

Public Rights-of-Way

(Curb Ramps)

Intersection ID: 47035	Main Street: W_ARROWOOD_RD	Cross Street: STONEGROVE_LN	Location: NW
ADA ID: 2A7E459EC205	Ramp Type: Perp	Initial Pass/Fail: Pass	Overall Compliance: No
Severity Score: 2.5			
Codes/Mitigation Info/Possible Solution		Field Measurements/Component Compliance

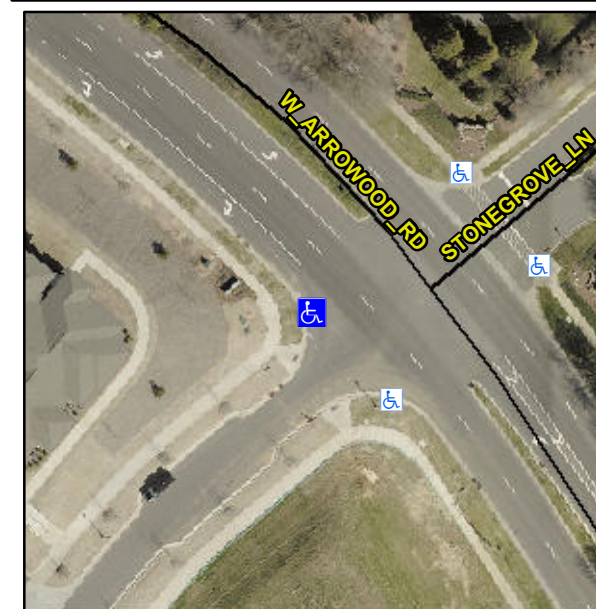
Compliance	Description	Data	Compliance	Description	Data
N/A	Ramp Length (in)	71.0	Yes	Ramp Slope (%)	5.8
Yes	Ramp Width (in)	60.0	Yes	Ramp XSlope (%)	0.9
N/A	Flare Type LT	Sloped	N/A	Flare Type RT	N/A
N/A	Flare Slope LT (%)	7.6	Yes	Flare Slope RT (%)	4.9
N/A	Flare Traversable LT?	Yes	N/A	Flare Traversable RT?	Yes
Yes	Landing Length (in)	61.0	Yes	DWS Provided?	Yes
Yes	Landing Width (in)	60.0	Yes	DWS Contrast?	Yes
No	Landing Slope (%)	4.3	Yes	DWS Length (in)	24.0
Yes	Landing X Slope (%)	0.5	No	DWS Full Width?	No
N/A	Landing Curb? (Y/N)	No	No	DWS Offset (in)	4.0
N/A	Shared Landing?	No			
Yes	Gutter Ponding?	No	Yes	Gutter Slope (%)	0.4
Yes	Gutter Lip Ht (in)	0.0	Yes	Gutter X Slope (%)	0.9
N/A	Painted X Walk1?	No	N/A	Painted X Walk2?	N/A
	X Walk 1 Direction	To SE		X Walk 2 Direction	N/A
N/A	X Walk 1 Width (in)	N/A	N/A	X Walk 2 Width (in)	N/A
	X Walk 1 Slope (%)	2.0		X Walk 2 Slope (%)	N/A
	X Walk 1 X Slope (%)	0.5		X Walk 2 X Slope (%)	N/A

N/A	Ramp inside XWalk1?	N/A	N/A	Ramp inside XWalk2?	N/A
	Road Slope (%)	N/A	N/A	Clear Space?	Yes
	Road X Slope (%)	N/A	N/A	Clear Space to XWalk (in)	N/A
Yes	Any Obstructions?	No	Yes	Storm Grate/Utility Hazard?	No
	Obstruction Type			Storm Grate/Utility Type	
		N/A			N/A
			Yes	Surface Condition? (G/P)	Good

Possible Solutions:

Remove & Replace Entire Ramp.

Not Found, R304.2.2-Perp, R304.3.2-Para, R305.1.4, R305.2

Total Cost: \$ 1850.00
