Access Compliance Report Public Rights-of-Way (Curb Ramps)

_	.									
Intersection ID: 23277	Main Street: S_TRYON_ST			Cross Street: JOHN_PRICE_RD				Location:	NW		
ADA ID: 2A80CB04DE46	2A80CB04DE46 Ramp Type: Perp			Initial I	Initial Pass/Fail: Fail Overall Compliance: No				o Severity Score:	25	
Codes/Mitigation Info/Possible Solution					Field Measurements/Component Compliance

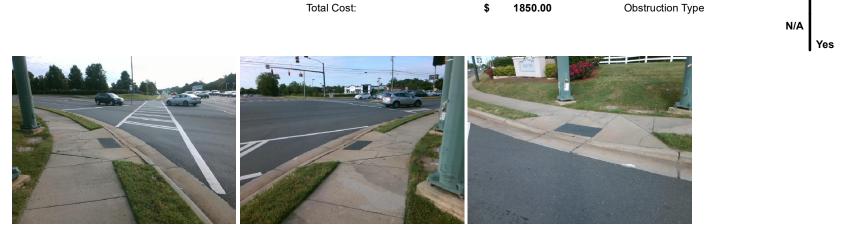
1. James and	Possible Solutions:			Compliance Description			Data Compliance Description			
		Remove & Replace En	tire Ramp).	N/A	Ramp Length (in)	60.0	No	Ramp Slope (%)	9.3

1.7				Yes	Ramp Width (in)	48.0	No	Ramp XSlope (%)	5.8	
	A Contraction				N/A	Flare Type LT	N/A	N/A	Flare Type RT	N/A	
E B	<u>k</u>				N/A	Flare Slope LT (%)	N/A	N/A	Flare Slope RT (%)	N/A	
	THE EX				N/A	Flare Traversable LT?	N/A	N/A	Flare Traversable RT?	N/A	
		e			N/A	Landing Length (in)	N/A	N/A	DWS Provided?	N/A	
Rev All Calle		Surveyor Notes:			N/A	Landing Width (in)	N/A	N/A	DWS Contrast?	N/A	
		N/A			N/A	Landing Slope (%)	N/A	N/A	DWS Length (in)	N/A	
					N/A	Landing X Slope (%)	N/A	N/A	DWS Full Width?	N/A	
the second se	X				N/A	Landing Curb? (Y/N)	N/A	N/A	DWS Offset (in)	N/A	
A A A A A A A A A A A A A A A A A A A	Pro Al				N/A	Shared Landing?	N/A				
54	Non	PROW/ADA:			N/A	Gutter Ponding?	N/A	N/A	Gutter Slope (%)	N/A	
Not Found, R304.2.			R304.5.3		N/A	Gutter Lip Ht (in)	N/A	N/A	Gutter X Slope (%)	N/A	
por 4	NY 1 12	, , , , , , , , , , , , , , , , , , , ,			N/A	Painted X Walk1?	Yes	N/A	Painted X Walk2?	N/A
