# Access Compliance Report

## Public Rights-of-Way

### (Curb Ramps)

| Intersection ID: 10158 | Main Street: MULBERRY_CHURCH_RD | Cross Street: TUCKASEEGEE_RD | Location: SW |

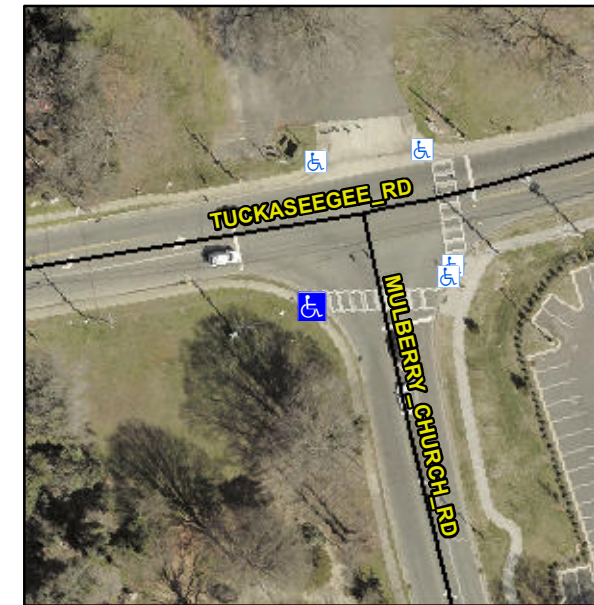
| ADA ID: 2A83B362A30F | Ramp Type: Perp | Initial Pass/Fail: Fail | Overall Compliance: No |
| | | Severity Score: 8.75 | |

**Not Found, R304.5.1**

| Compliance | Description | Data | Compliance | Description | Data |
|---|---|---|---|---|---|
| No | Ramp Width (in) | 39.5 | Yes | Ramp XSlope (%) | 0.5 |

**Remove & Replace Entire Ramp.**

Total Cost: \$ 1850.00
