# Access Compliance Report

## Public Rights-of-Way

### (Curb Ramps)

Intersection ID: 28233	Main Street: DARBY_CHASE_DR	Cross Street: N/A	Location: NW
ADA ID: 2A8B19AA23CD	Ramp Type: Perp	Initial Pass/Fail: Fail	Overall Compliance: No
Codes/Mitigation Info/Possible Solution		Field Measurements/Component Compliance

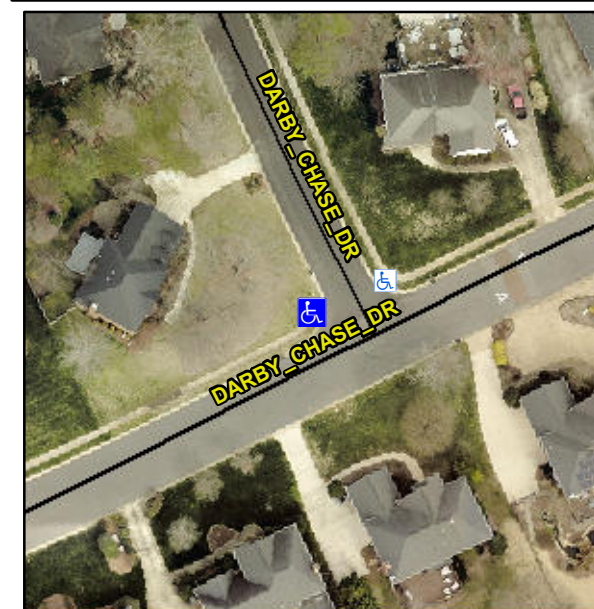
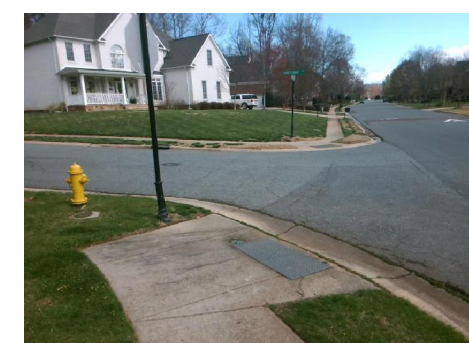
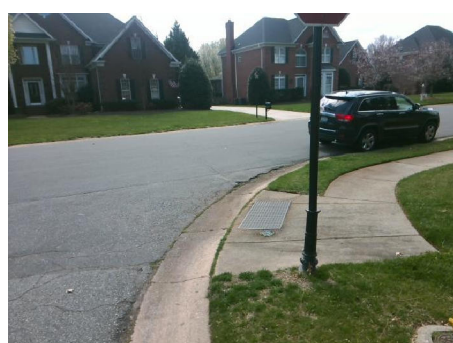
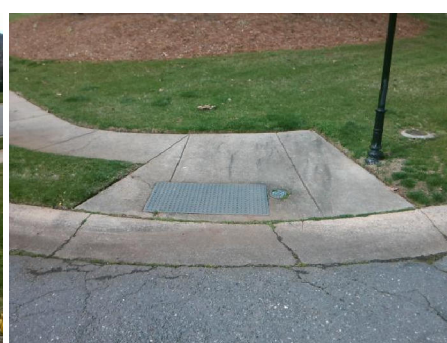
**Not Found, R304.2.2, R304.5.3**

Compliance	Description	Data	Compliance	Description	Data
N/A	Ramp Length (in)	94.0	No	Ramp Slope (%)	8.4
Yes	Ramp Width (in)	52.0	No	Ramp XSlope (%)	2.3
N/A	Flare Type LT	N/A	N/A	Flare Type RT	N/A
N/A	Flare Slope LT (%)	N/A	N/A	Flare Slope RT (%)	N/A
N/A	Flare Traversable LT?	N/A	N/A	Flare Traversable RT?	N/A
N/A	Landing Length (in)	N/A	N/A	DWS Provided?	N/A
N/A	Landing Width (in)	N/A	N/A	DWS Contrast?	N/A
N/A	Landing Slope (%)	N/A	N/A	DWS Length (in)	N/A
N/A	Landing X Slope (%)	N/A	N/A	DWS Full Width?	N/A
N/A	Landing Curb? (Y/N)	N/A	N/A	DWS Offset (in)	N/A
N/A	Shared Landing?	N/A			
N/A	Gutter Ponding?	N/A	N/A	Gutter Slope (%)	N/A
N/A	Gutter Lip Ht (in)	N/A	N/A	Gutter X Slope (%)	N/A
N/A	Painted X Walk1?	No	N/A	Painted X Walk2?	N/A
	X Walk 1 Direction	To NE		X Walk 2 Direction	N/A
N/A	X Walk 1 Width (in)	N/A	N/A	X Walk 2 Width (in)	N/A
	X Walk 1 Slope (%)	0.4		X Walk 2 Slope (%)	N/A
	X Walk 1 X Slope (%)	0.1		X Walk 2 X Slope (%)	N/A

N/A	Ramp inside XWalk1?	N/A	N/A	Ramp inside XWalk2?	N/A
	Road Slope (%)	N/A	N/A	Clear Space?	N/A
	Road X Slope (%)	N/A	N/A	Clear Space to XWalk (in)	N/A
N/A	Any Obstructions?	N/A	N/A	Storm Grate/Utility Hazard?	N/A
	Obstruction Type			Storm Grate/Utility Type	
		N/A			N/A
			Yes	Surface Condition? (G/P)	Good

**Remove & Replace Entire Ramp.**

Total Cost: \$ 1850.00
