# Access Compliance Report

## Public Rights-of-Way

### (Curb Ramps)

Intersection ID: 11488	Main Street: N_CHURCH_ST	Cross Street: W_12TH_ST	Location:	E
ADA ID: 2A99E905E09D	Ramp Type: Para	Initial Pass/Fail: Fail	Overall Compliance: No	Severity Score: 25
Codes/Mitigation Info/Possible Solution		Field Measurements/Component Compliance

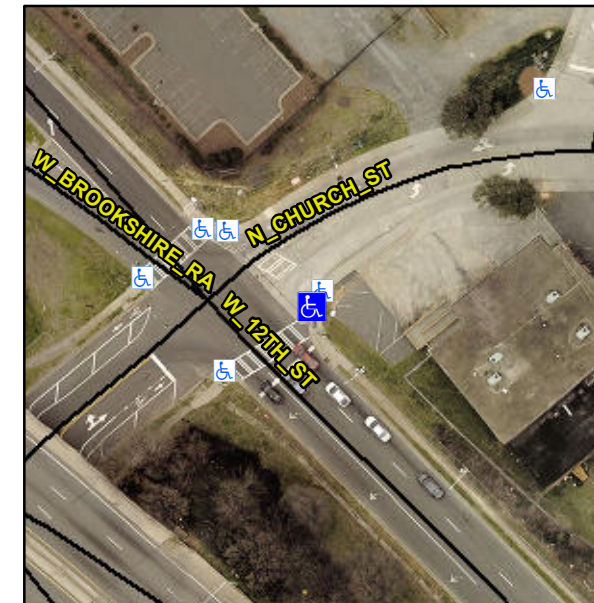
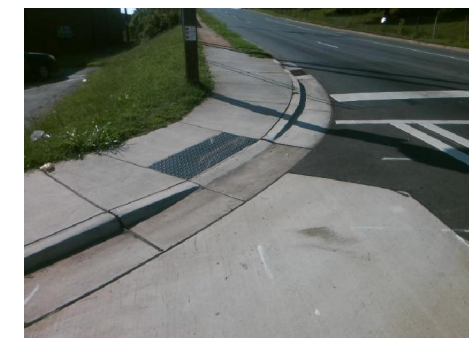
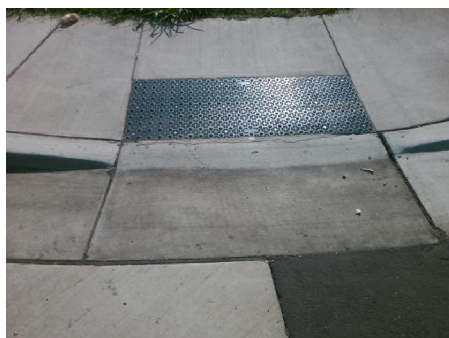
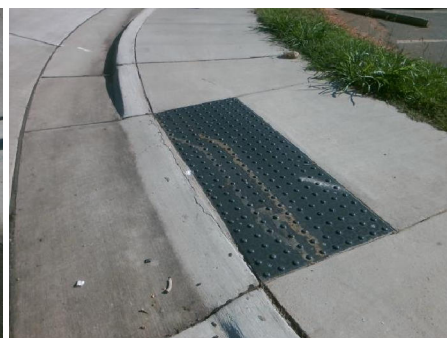
Compliance	Description	Data	Compliance	Description	Data
N/A	Ramp Length LT (in)	25.5	N/A	Ramp Length RT (in)	50.5
Yes	Ramp Width LT (in)	59.5	Yes	Ramp Width RT (in)	60.0
Yes	Ramp Slope LT (%)	6.6	No	Ramp Slope RT (%)	13.0
Yes	Ramp XSlope LT (%)	0.2	Yes	Ramp XSlope RT (%)	1.6
N/A	Landing Length (in)	N/A	N/A	DWS Provided?	N/A
N/A	Landing Width (in)	N/A	N/A	DWS Contrast?	N/A
N/A	Landing Slope (%)	N/A	N/A	DWS Length (in)	N/A
N/A	Landing X Slope (%)	N/A	N/A	DWS Full Width?	N/A
N/A	Landing Curb? (Y/N)	N/A	N/A	DWS Offset (in)	N/A
N/A	Shared Landing?	N/A			
N/A	Gutter Ponding?	N/A	N/A	Gutter Slope (%)	N/A
N/A	Gutter Lip Ht (in)	N/A	N/A	Gutter X Slope (%)	N/A
N/A	Painted X Walk1?	No	N/A	Painted X Walk2?	N/A
	X Walk 1 Direction	To SW		X Walk 2 Direction	N/A
N/A	X Walk 1 Width (in)	N/A	N/A	X Walk 2 Width (in)	N/A
	X Walk 1 Slope (%)	3.6		X Walk 2 Slope (%)	N/A
	X Walk 1 X Slope (%)	3.2		X Walk 2 X Slope (%)	N/A
N/A	Ramp inside XWalk1?	N/A	N/A	Ramp inside XWalk2?	N/A

Road Slope (%)	N/A	N/A	Clear Space?	N/A
	Road X Slope (%)	N/A	N/A	Clear Space to XWalk (in)	N/A
N/A	Any Obstructions?	N/A	N/A	Storm Grate/Utility Hazard?	N/A
	Obstruction Type			Storm Grate/Utility Type	
		N/A			N/A
			Yes	Surface Condition? (G/P)	Good
			N/A	Curb Slope (%)	10.7

**Remove & Replace Entire Ramp.**

**R304.3.2**
