Access Compliance Report

Public Rights-of-Way

| Intersection ID: 12505 | Main Street: OLD_STEELE_CREEK_RD | Cross Street: WESTERLY_HILLS_DR | Location: NW |
| ADA ID: 2A9AA3089EA6 | Ramp Type: PerpDiag | Initial Pass/Fail: Fail | Overall Compliance: No |

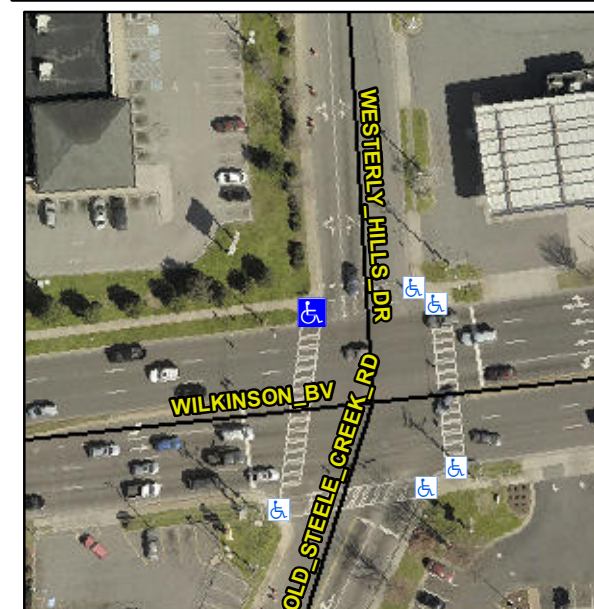
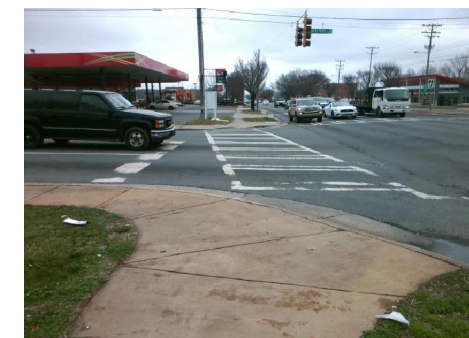
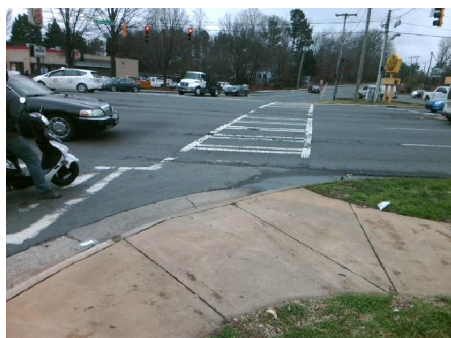
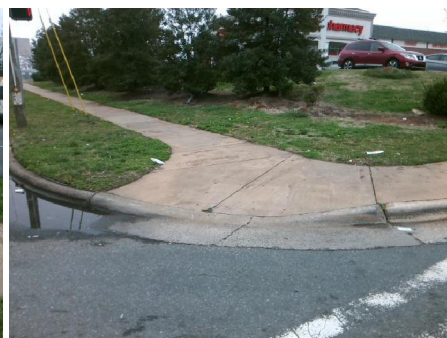
Not Found, R304.5.1, R304.2.2

| Compliance | Description | Data | Compliance | Description | Data |
|---|---|---|---|---|---|
| N/A | Ramp Length (in) | 72.0 | No | Ramp Slope (%) | 9.1 |
| No | Ramp Width (in) | 45.0 | Yes | Ramp XSlope (%) | 2.0 |

Remove & Replace Curb Ramp With Two New Directional Ramps or Equivalent.
