# Access Compliance Report

## Public Rights-of-Way

### (Curb Ramps)

| Intersection ID: 20540 | Main Street: FAIRVIEW_RD | Cross Street: VALENCIA_TR | Location: NE |

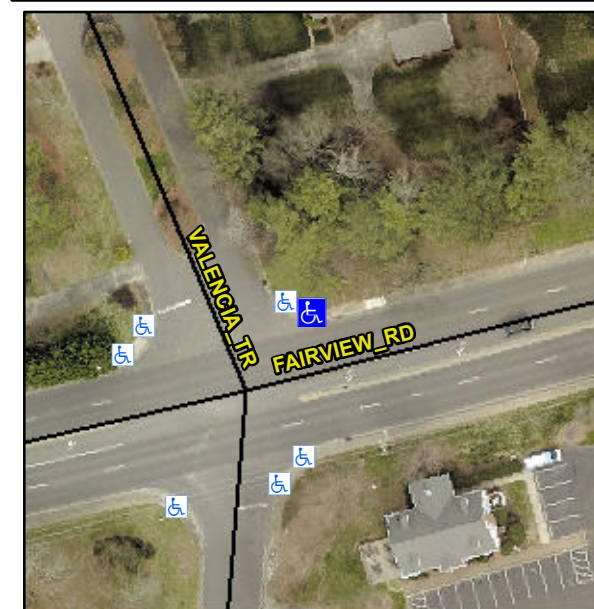
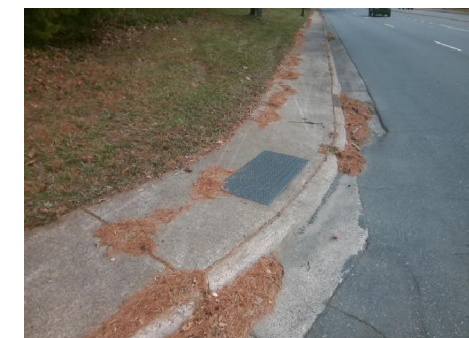
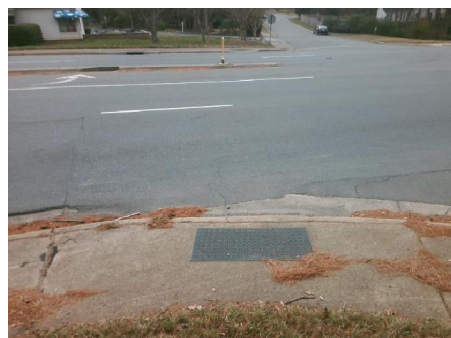
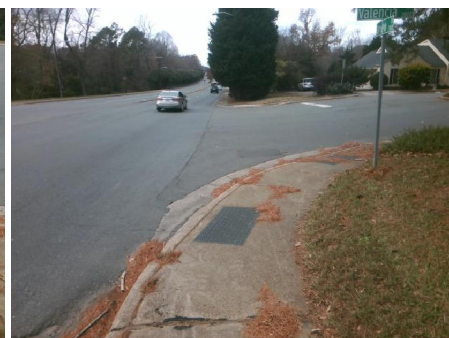
**Not Found, R304.2.1, R304.2.2-Perp, R304.3.2-Para, R304.5.3, R305.1.4, R305.2**

| Compliance | Description | Data | Compliance | Description | Data |
|---|---|---|---|---|---|
| No | Landing Length (in) | N/A | Yes | DWS Provided? | Yes |
| No | Landing Width (in) | N/A | Yes | DWS Contrast? | Yes |
| No | Landing Slope (%) | N/A | Yes | DWS Length (in) | 24.0 |
| No | Landing X Slope (%) | N/A | No | DWS Full Width? | No |
| N/A | Landing Curb? (Y/N) | No | No | DWS Offset (in) | 5.0 |

**Remove & Replace Entire Ramp.**
