Access Compliance Report Public Rights-of-Way (Curb Ramps)

· · · · · · · · · · · · · · · ·											
Intersection ID: 50612	Main Street: YELLOW_OAK_RD				Street:	DOWNY_BIRCH_RD	Location:	NE			
ADA ID: 2AA1BDC2B630	A ID: 2AA1BDC2B630 Ramp Type: Perp				Initial Pass/Fail: Pass Overall Compliance: No				o Severity Score:	5.25	
Codes/Mitigation Info/Possible Solution					Field Measurements/Component Compliance						
		Possible Solutions:			Compliance Description			Data Compliance Description			
	a 3 .	Remove & Replace Enti	ire Ram	n	N/A	Ramp Length (in)	48.0		Ramp Slope (%)	5.9	
	E I	Remove & Replace Gut		.6.	Yes	Ramp Width (in)	48.0		Ramp XSlope (%)	3.8	
	Star Ital				N/A	Flare Type LT	Sloped	N/A	Flare Type RT	N/A	
	<u>a</u> <u>a</u>				N/A	Flare Slope LT (%)		N/A	Flare Slope RT (%)	0.5	
A A A A A A A A A A A A A A A A A A A	6. 6. C				N/A	Flare Traversable LT?	No	N/A	Flare Traversable RT?	No	
ALLON A AN	A C	1			Yes	Landing Length (in)	48.0	Yes	DWS Provided?	Yes

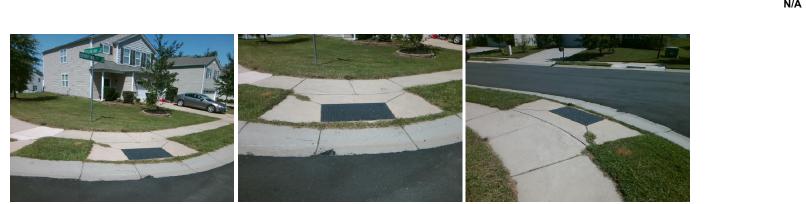
Surveyor Notes:			Yes	Landing Width (in)	84.0	Yes	DWS Contrast?	Yes	
		N/A			Yes	Landing Slope (%)	1.1	Yes	DWS Length (in)	24.5	
The second se					No	Landing X Slope (%)	5.2	Yes	DWS Full Width?	Yes	
				N/A	Landing Curb? (Y/N)	No	No	DWS Offset (in)	5.5		
					N/A	Shared Landing?	No				
7 // 5	ALI	PROW/ADA:			Yes	Gutter Ponding?	No	No	Gutter Slope (%)	8.4	
	in the second	Not Found, R304.5.3, R305.2	305 2		Yes	Gutter Lip Ht (in)	0.0	No	Gutter X Slope (%)	4.1	
	R his	R304.5.4			N/A	Painted X Walk1?	No	N/A	Painted X Walk2?	N/A	
						X Walk 1 Direction	To S		X Walk 2 Direction	N/A	
					N/A	X Walk 1 Width (in)	N/A	N/A	X Walk 2 Width (in)	N/A	
Street 1 Name	DOWNY BIRCH RD	-				X Walk 1 Slope (%)	1.1		X Walk 2 Slope (%)	N/A	
Stop Condition-Street 2	None					X Walk 1 X Slope (%)	3.7		X Walk 2 X Slope (%)	N/A	
Street 2 Name	N/A				N/A	Ramp inside XWalk1?	N/A	N/A	Ramp inside XWalk2?	N/A	
Stop Condition-Street 1	N/A					Road Slope (%)	N/A	N/A	Clear Space?	Yes

Road X Slope (%)	N/A	N/A	Clear Space to XWalk (in)	N/A	
					Yes	Any Obstructions?	No	Yes	Storm Grate/Utility Hazard?	No	
		Total Cost:	\$	2600.00		Obstruction Type			Storm Grate/Utility Type		
							N/A			N/A
