Access Compliance Report

Public Rights-of-Way

(Curb Ramps)

Intersection ID: 28506	Main Street: BIRD_WATCH_LN	Cross Street: RED_FINCH_LN	Location: W
ADA ID: 2AA20EB74BB6	Ramp Type: BlendTrans2	Initial Pass/Fail: Fail	Overall Compliance: No
Severity Score: 36.25			
Codes/Mitigation Info/Possible Solution		Field Measurements/Component Compliance

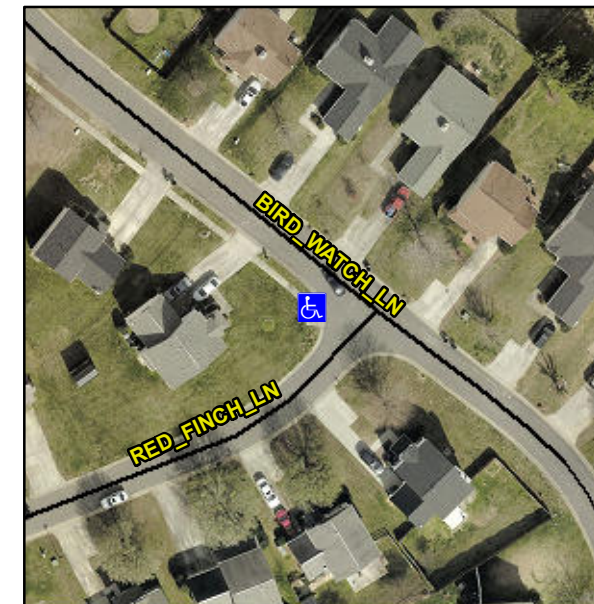
Not Found, R304.5.1, R304.5.3

Compliance	Description	Data	Compliance	Description	Data
N/A	Ramp Length (in)	95.0	Yes	BlendTrans Slope (%)	1.9
No	Ramp Width (in)	31.5	No	BlendTrans XSlope (%)	4.8
N/A	Flare Type LT	N/A	N/A	Flare Type RT	N/A
N/A	Flare Slope LT (%)	N/A	N/A	Flare Slope RT (%)	N/A
N/A	Flare Traversable LT?	N/A	N/A	Flare Traversable RT?	N/A
N/A	Landing Length (in)	N/A	N/A	DWS Provided?	N/A
N/A	Landing Width (in)	N/A	N/A	DWS Contrast?	N/A
N/A	Landing Slope (%)	N/A	N/A	DWS Length (in)	N/A
N/A	Landing X Slope (%)	N/A	N/A	DWS Full Width?	N/A
N/A	Landing Curb? (Y/N)	N/A	N/A	DWS Offset (in)	N/A
N/A	Shared Landing?	N/A			
N/A	Gutter Ponding?	N/A	N/A	Gutter Slope (%)	N/A
N/A	Gutter Lip Ht (in)	N/A	N/A	Gutter X Slope (%)	N/A
N/A	Painted X Walk1?	No	N/A	Painted X Walk2?	No
	X Walk 1 Direction	To SE		X Walk 2 Direction	To NE
	X Walk 1 Width (in)	N/A		X Walk 2 Width (in)	N/A
	X Walk 1 Slope (%)	N/A		X Walk 2 Slope (%)	N/A
	X Walk 1 X Slope (%)	N/A		X Walk 2 X Slope (%)	N/A

N/A	Ramp inside XWalk1?	N/A	N/A	Ramp inside XWalk2?	N/A
	Road Slope (%)	3.8		Clear Space?	N/A
	Road X Slope (%)	7.1	N/A	Clear Space to XWalk (in)	N/A
N/A	Any Obstructions?	N/A	N/A	Storm Grate/Utility Hazard?	N/A
	Obstruction Type			Storm Grate/Utility Type	
		N/A			N/A
			Yes	Surface Condition? (G/P)	Good
			No	Curb Slope (%)	16.3

Remove & Replace Curb Ramp With Two New Directional Ramps or Equivalent.
