Access Compliance Report

Public Rights-of-Way

(Curb Ramps)

Intersection ID: 53284	Main Street: BENFIELD_RD	Cross Street: ROBERT_HELMS_RD	Location: S
ADA ID: 2AA8A47E5EBA	Ramp Type: Perp	Initial Pass/Fail: Fail	Overall Compliance: No
Severity Score: 12.5			
Codes/Mitigation Info/Possible Solution		Field Measurements/Component Compliance

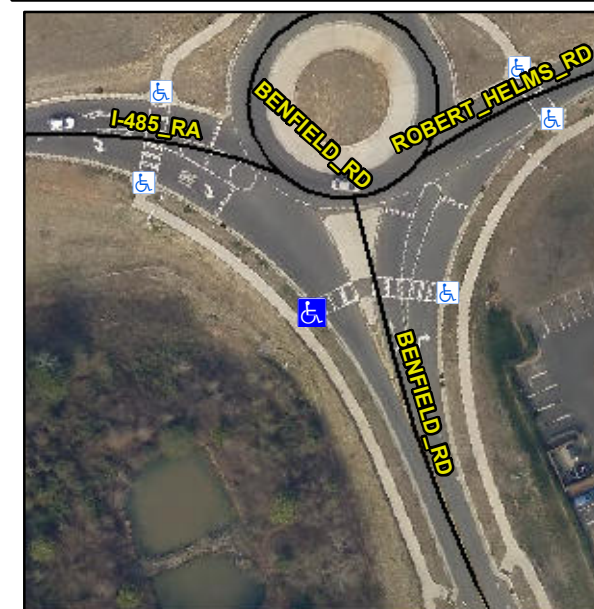
Compliance	Description	Data	Compliance	Description	Data
N/A	Ramp Length (in)	94.5	No	Ramp Slope (%)	8.6
Yes	Ramp Width (in)	48.0	Yes	Ramp XSlope (%)	1.7
N/A	Flare Type LT	N/A	N/A	Flare Type RT	N/A
N/A	Flare Slope LT (%)	N/A	N/A	Flare Slope RT (%)	N/A
N/A	Flare Traversable LT?	N/A	N/A	Flare Traversable RT?	N/A
N/A	Landing Length (in)	N/A	N/A	DWS Provided?	N/A
N/A	Landing Width (in)	N/A	N/A	DWS Contrast?	N/A
N/A	Landing Slope (%)	N/A	N/A	DWS Length (in)	N/A
N/A	Landing X Slope (%)	N/A	N/A	DWS Full Width?	N/A
N/A	Landing Curb? (Y/N)	N/A	N/A	DWS Offset (in)	N/A
N/A	Shared Landing?	N/A			
N/A	Gutter Ponding?	N/A	N/A	Gutter Slope (%)	N/A
N/A	Gutter Lip Ht (in)	N/A	N/A	Gutter X Slope (%)	N/A
N/A	Painted X Walk1?	Yes	N/A	Painted X Walk2?	N/A
	X Walk 1 Direction	To E		X Walk 2 Direction	N/A
N/A	X Walk 1 Width (in)	106.0	N/A	X Walk 2 Width (in)	N/A
	X Walk 1 Slope (%)	3.9		X Walk 2 Slope (%)	N/A
	X Walk 1 X Slope (%)	1.9		X Walk 2 X Slope (%)	N/A

N/A	Ramp inside XWalk1?	Yes	N/A	Ramp inside XWalk2?	N/A
	Road Slope (%)	N/A	N/A	Clear Space?	N/A
	Road X Slope (%)	N/A	N/A	Clear Space to XWalk (in)	N/A
N/A	Any Obstructions?	N/A	N/A	Storm Grate/Utility Hazard?	N/A
	Obstruction Type			Storm Grate/Utility Type	
		N/A			N/A
			Yes	Surface Condition? (G/P)	Good

Remove & Replace Entire Ramp.
