Access Compliance Report

Public Rights-of-Way

(Curb Ramps)

Intersection ID: 17570	Main Street: RANDOLPH_RD	Cross Street: WOODLARK_LN	Location: S
ADA ID: 2AB17EE588D4	Ramp Type: Perp	Initial Pass/Fail: Fail	Overall Compliance: No
Codes/Mitigation Info/Possible Solution		Field Measurements/Component Compliance	
Severity Score: 33.75

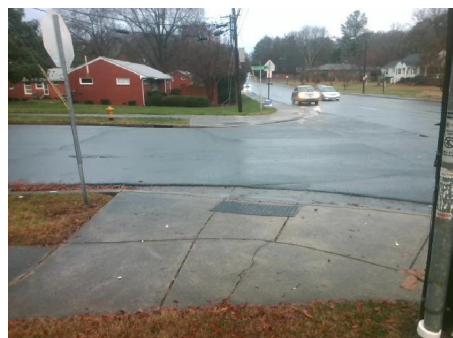
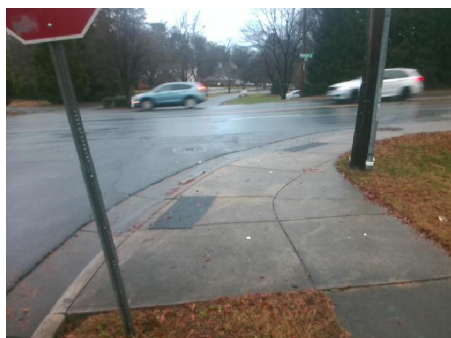
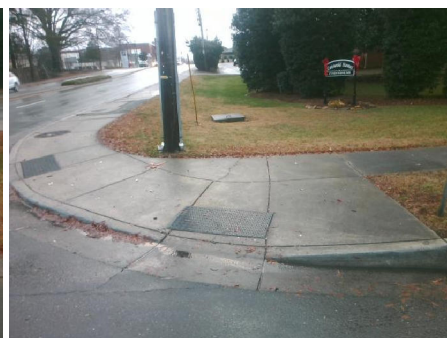
Not Found, R304.5.1, R304.2.2, R304.5.3

Compliance	Description	Data	Compliance	Description	Data
N/A	Ramp Length (in)	72.0	No	Ramp Slope (%)	9.4
No	Ramp Width (in)	36.5	No	Ramp XSlope (%)	5.5
N/A	Flare Type LT	N/A	N/A	Flare Type RT	N/A
N/A	Flare Slope LT (%)	N/A	N/A	Flare Slope RT (%)	N/A
N/A	Flare Traversable LT?	N/A	N/A	Flare Traversable RT?	N/A
N/A	Landing Length (in)	N/A	N/A	DWS Provided?	N/A
N/A	Landing Width (in)	N/A	N/A	DWS Contrast?	N/A
N/A	Landing Slope (%)	N/A	N/A	DWS Length (in)	N/A
N/A	Landing X Slope (%)	N/A	N/A	DWS Full Width?	N/A
N/A	Landing Curb? (Y/N)	N/A	N/A	DWS Offset (in)	N/A
N/A	Shared Landing?	N/A			
N/A	Gutter Ponding?	N/A	N/A	Gutter Slope (%)	N/A
N/A	Gutter Lip Ht (in)	N/A	N/A	Gutter X Slope (%)	N/A
N/A	Painted X Walk1?	No	N/A	Painted X Walk2?	N/A
	X Walk 1 Direction	To NW		X Walk 2 Direction	N/A
N/A	X Walk 1 Width (in)	N/A	N/A	X Walk 2 Width (in)	N/A
	X Walk 1 Slope (%)	1.3		X Walk 2 Slope (%)	N/A
	X Walk 1 X Slope (%)	4.2		X Walk 2 X Slope (%)	N/A

N/A	Ramp inside XWalk1?	N/A	N/A	Ramp inside XWalk2?	N/A
	Road Slope (%)	N/A	N/A	Clear Space?	N/A
	Road X Slope (%)	N/A	N/A	Clear Space to XWalk (in)	N/A
N/A	Any Obstructions?	N/A	N/A	Storm Grate/Utility Hazard?	N/A
	Obstruction Type			Storm Grate/Utility Type	
		N/A			N/A
			Yes	Surface Condition? (G/P)	Good

Remove & Replace Entire Ramp.
