Access Compliance Report

Public Rights-of-Way

(Curb Ramps)

Intersection ID: N/A	Main Street: MONROE_RD	Cross Street: BRAMLET_RD	Location: NE
ADA ID: 2AB355565C7E	Ramp Type: PerpDiag	Initial Pass/Fail: Fail	Overall Compliance: No
Codes/Mitigation Info/Possible Solution		Field Measurements/Component Compliance

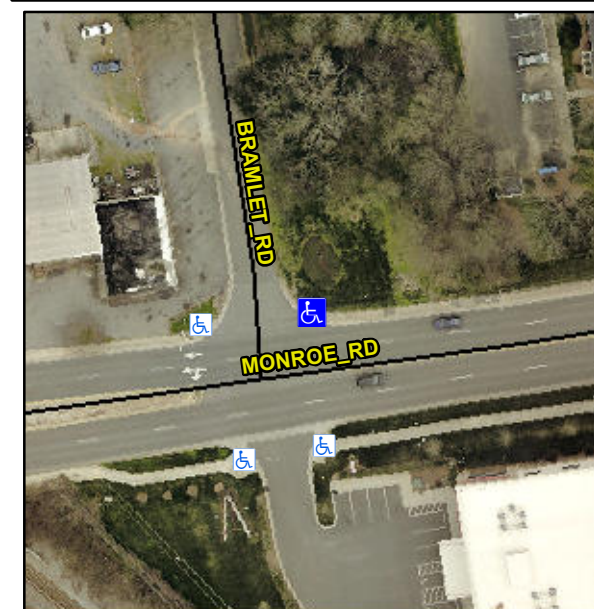
Not Found, R304.5.1, R304.2.2, R304.5.3

Compliance	Description	Data	Compliance	Description	Data
N/A	Ramp Length (in)	62.0	No	Ramp Slope (%)	12.4
No	Ramp Width (in)	40.5	No	Ramp XSlope (%)	8.1
N/A	Flare Type LT	N/A	N/A	Flare Type RT	N/A
N/A	Flare Slope LT (%)	N/A	N/A	Flare Slope RT (%)	N/A
N/A	Flare Traversable LT?	N/A	N/A	Flare Traversable RT?	N/A
N/A	Landing Length (in)	N/A	N/A	DWS Provided?	N/A
N/A	Landing Width (in)	N/A	N/A	DWS Contrast?	N/A
N/A	Landing Slope (%)	N/A	N/A	DWS Length (in)	N/A
N/A	Landing X Slope (%)	N/A	N/A	DWS Full Width?	N/A
N/A	Landing Curb? (Y/N)	N/A	N/A	DWS Offset (in)	N/A
N/A	Shared Landing?	N/A			
N/A	Gutter Ponding?	N/A	N/A	Gutter Slope (%)	N/A
N/A	Gutter Lip Ht (in)	N/A	N/A	Gutter X Slope (%)	N/A
N/A	Painted X Walk1?	No	N/A	Painted X Walk2?	No
	X Walk 1 Direction	To W		X Walk 2 Direction	To S
N/A	X Walk 1 Width (in)	N/A	N/A	X Walk 2 Width (in)	N/A
	X Walk 1 Slope (%)	0.9		X Walk 2 Slope (%)	8.2
	X Walk 1 X Slope (%)	12.6		X Walk 2 X Slope (%)	1.6

N/A	Ramp inside XWalk1?	N/A	N/A	Ramp inside XWalk2?	N/A
	Road Slope (%)	5.6	N/A	Clear Space?	N/A
	Road X Slope (%)	8.8	N/A	Clear Space to XWalk (in)	N/A
N/A	Any Obstructions?	N/A	N/A	Storm Grate/Utility Hazard?	N/A
	Obstruction Type			Storm Grate/Utility Type	
		N/A			N/A
			Yes	Surface Condition? (G/P)	Good

Remove & Replace Curb Ramp With Two New Directional Ramps or Equivalent.

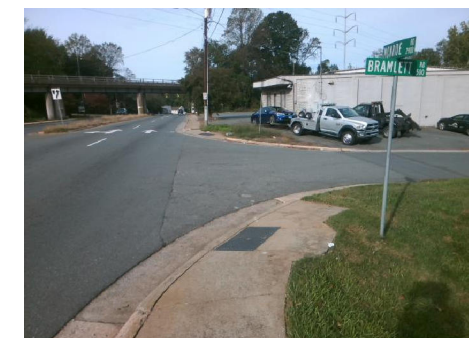
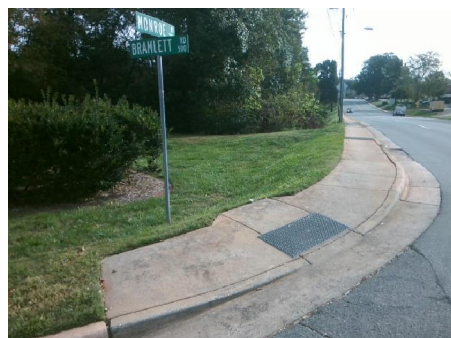
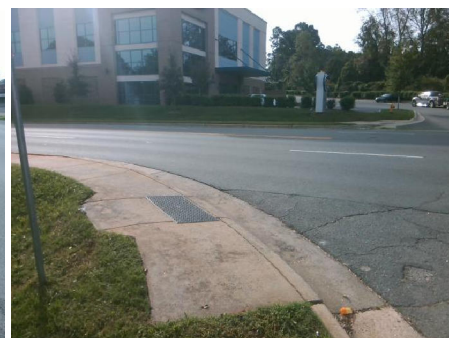
Street 1 Name **BRAMLETT RD**
 Stop Condition-Street 2 **StopSign**
 Street 2 Name **MONROE RD**
 Stop Condition-Street 1 **None**
