Access Compliance Report

Public Rights-of-Way

(Curb Ramps)

Intersection ID: 48495	Main Street: LOCH_LOMOND_DR	Cross Street: BEREWICK_COMMONS_PY	Location: S
ADA ID: 2AB533EFD640	Ramp Type: Perp	Initial Pass/Fail: Fail	Overall Compliance: No
Severity Score: 12.5			
Codes/Mitigation Info/Possible Solution		Field Measurements/Component Compliance

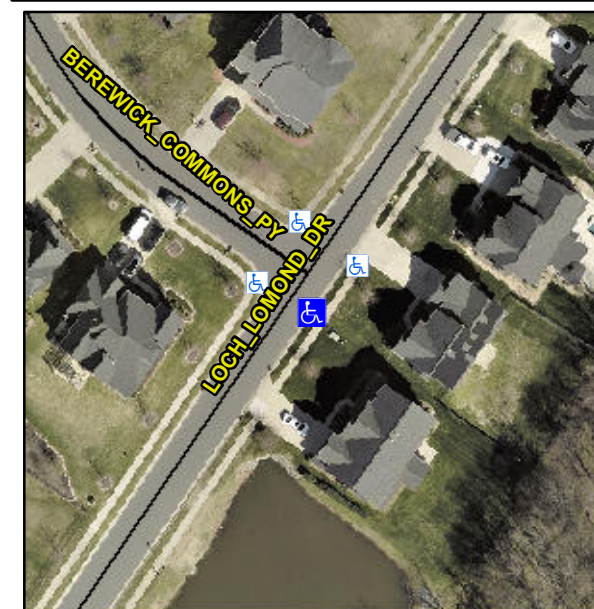
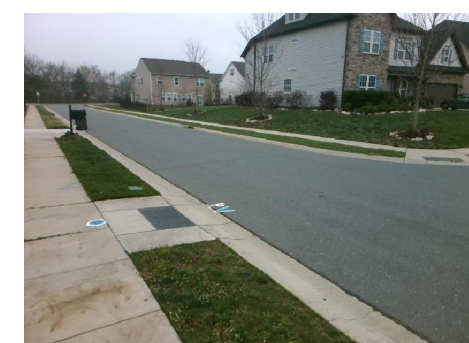
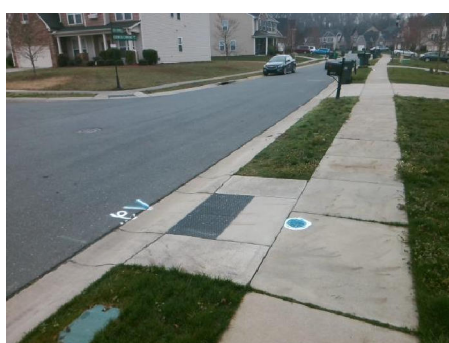
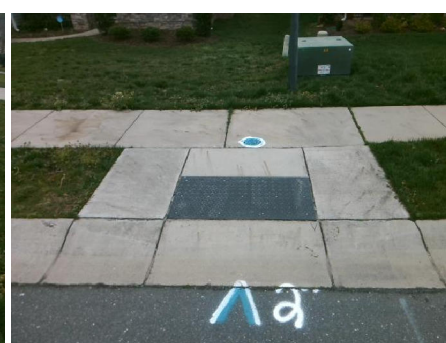
Not Found, R304.2.2

Compliance	Description	Data	Compliance	Description	Data
N/A	Ramp Length (in)	47.0	No	Ramp Slope (%)	8.9
Yes	Ramp Width (in)	48.0	Yes	Ramp XSlope (%)	0.7
N/A	Flare Type LT	N/A	N/A	Flare Type RT	N/A
N/A	Flare Slope LT (%)	N/A	N/A	Flare Slope RT (%)	N/A
N/A	Flare Traversable LT?	N/A	N/A	Flare Traversable RT?	N/A
N/A	Landing Length (in)	N/A	N/A	DWS Provided?	N/A
N/A	Landing Width (in)	N/A	N/A	DWS Contrast?	N/A
N/A	Landing Slope (%)	N/A	N/A	DWS Length (in)	N/A
N/A	Landing X Slope (%)	N/A	N/A	DWS Full Width?	N/A
N/A	Landing Curb? (Y/N)	N/A	N/A	DWS Offset (in)	N/A
N/A	Shared Landing?	N/A			
N/A	Gutter Ponding?	N/A	N/A	Gutter Slope (%)	N/A
N/A	Gutter Lip Ht (in)	N/A	N/A	Gutter X Slope (%)	N/A
N/A	Painted X Walk1?	No	N/A	Painted X Walk2?	N/A
	X Walk 1 Direction	To NW		X Walk 2 Direction	N/A
N/A	X Walk 1 Width (in)	N/A	N/A	X Walk 2 Width (in)	N/A
	X Walk 1 Slope (%)	2.7		X Walk 2 Slope (%)	N/A
	X Walk 1 X Slope (%)	0.8		X Walk 2 X Slope (%)	N/A

N/A	Ramp inside XWalk1?	N/A	N/A	Ramp inside XWalk2?	N/A
	Road Slope (%)	N/A	N/A	Clear Space?	N/A
	Road X Slope (%)	N/A	N/A	Clear Space to XWalk (in)	N/A
N/A	Any Obstructions?	N/A	N/A	Storm Grate/Utility Hazard?	N/A
	Obstruction Type			Storm Grate/Utility Type	
		N/A			N/A
			Yes	Surface Condition? (G/P)	Good

Remove & Replace Entire Ramp.
