Access Compliance Report Public Rights-of-Way (Curb Ramps)

Intersection ID: 10040213Main Street: TYVOLA_RDCross Street: N/ALocation:SWADA ID: 2AB9ADDF0167Ramp Type: PerpDiagInitial Pass/Fail: FailOverall Compliance: NoSeverity Score:25

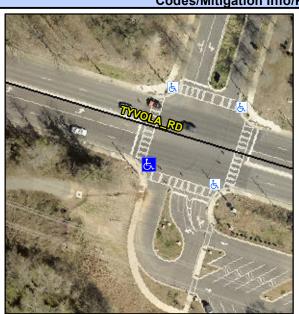
PROW/ADA:
Not Found, R304.5.3

Field Measurements/Component Compliance					
Compliance Description		Data	Compliance Description		Data
N/A	Ramp Length (in)	57.5	Yes	Ramp Slope (%)	5.2
Yes	Ramp Width (in)	186.0	No	Ramp XSlope (%)	8.8
N/A	Flare Type LT	N/A	N/A	Flare Type RT	N/A
N/A	Flare Slope LT (%)	N/A	N/A	Flare Slope RT (%)	N/A
N/A	Flare Traversable LT?	N/A	N/A	Flare Traversable RT?	N/A
N/A	Landing Length (in)	N/A	N/A	DWS Provided?	N/A
N/A	Landing Width (in)	N/A	N/A	DWS Contrast?	N/A
N/A	Landing Slope (%)	N/A	N/A	DWS Length (in)	N/A
N/A	Landing X Slope (%)	N/A	N/A	DWS Full Width?	N/A
N/A	Landing Curb? (Y/N)	N/A	N/A	DWS Offset (in)	N/A
N/A	Shared Landing?	N/A			
N/A	Gutter Ponding?	N/A	N/A	Gutter Slope (%)	N/A
N/A	Gutter Lip Ht (in)	N/A	N/A	Gutter X Slope (%)	N/A
N/A	Painted X Walk1?	No	N/A	Painted X Walk2?	No
	X Walk 1 Direction	То Е		X Walk 2 Direction	To N
N/A	X Walk 1 Width (in)	N/A	N/A	X Walk 2 Width (in)	N/A
	X Walk 1 Slope (%)	4.1		X Walk 2 Slope (%)	0.9

X Walk 1 X Slope (%)	6.0		X Walk 2 X Slope (%)	3.4
N/A	Ramp inside XWalk1?	N/A	N/A	Ramp inside XWalk2?	N/A
	Road Slope (%)	4.2	N/A	Clear Space?	N/A
	Road X Slope (%)	3.6	N/A	Clear Space to XWalk (in)	N/A
N/A	Any Obstructions?	N/A	N/A	Storm Grate/Utility Hazard?	N/A
	Obstruction Type		l	Storm Grate/Utility Type	
		N/A			N/A
			Yes	Surface Condition? (G/P)	Good
C 2011 O 1880

Remove & Replace Curb Ramp With
Two New Directional Ramps or
Equivalent.

Total Cost: \$ 3200.00
