Access Compliance Report

Public Rights-of-Way

(Curb Ramps)

Intersection ID: 42696	Main Street: SHARON_VIEW_RD	Cross Street: WINDING_CREEK_LN	Location: NW
ADA ID: 2AC10A9AB82E	Ramp Type: PerpDiag	Initial Pass/Fail: Fail	Overall Compliance: No
Severity Score: 58.75			
Codes/Mitigation Info/Possible Solution		Field Measurements/Component Compliance

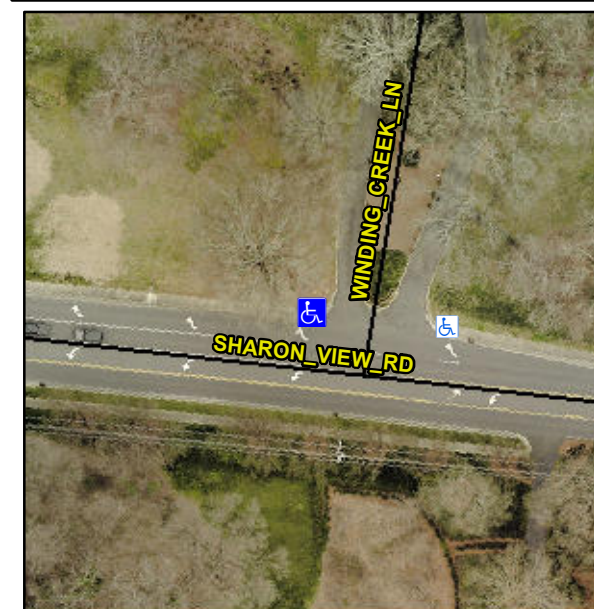
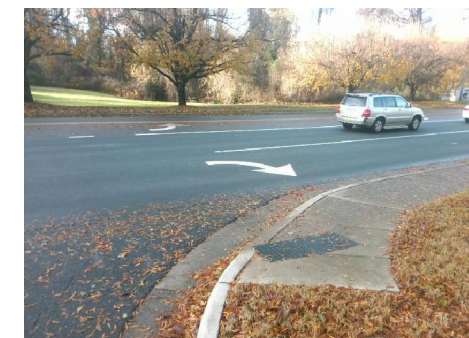
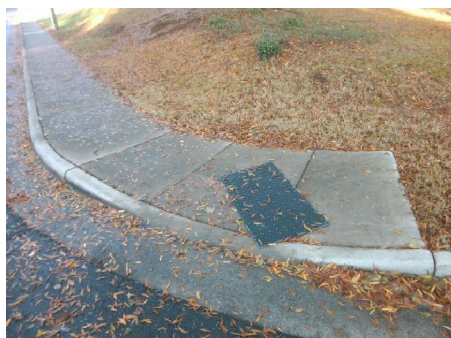
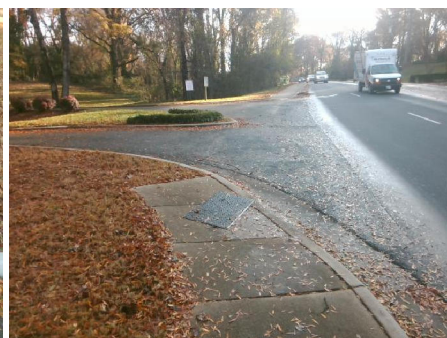
Not Found, R304.5.1, R304.2.2, R304.5.3

Compliance	Description	Data	Compliance	Description	Data
N/A	Ramp Length (in)	58.0	No	Ramp Slope (%)	12.7
No	Ramp Width (in)	40.0	No	Ramp XSlope (%)	11.8
N/A	Flare Type LT	N/A	N/A	Flare Type RT	N/A
N/A	Flare Slope LT (%)	N/A	N/A	Flare Slope RT (%)	N/A
N/A	Flare Traversable LT?	N/A	N/A	Flare Traversable RT?	N/A
N/A	Landing Length (in)	N/A	N/A	DWS Provided?	N/A
N/A	Landing Width (in)	N/A	N/A	DWS Contrast?	N/A
N/A	Landing Slope (%)	N/A	N/A	DWS Length (in)	N/A
N/A	Landing X Slope (%)	N/A	N/A	DWS Full Width?	N/A
N/A	Landing Curb? (Y/N)	N/A	N/A	DWS Offset (in)	N/A
N/A	Shared Landing?	N/A			
N/A	Gutter Ponding?	N/A	N/A	Gutter Slope (%)	N/A
N/A	Gutter Lip Ht (in)	N/A	N/A	Gutter X Slope (%)	N/A
N/A	Painted X Walk1?	No	N/A	Painted X Walk2?	No
	X Walk 1 Direction	To SW		X Walk 2 Direction	To SE
N/A	X Walk 1 Width (in)	N/A	N/A	X Walk 2 Width (in)	N/A
	X Walk 1 Slope (%)	5.4		X Walk 2 Slope (%)	9.2
	X Walk 1 X Slope (%)	9.3		X Walk 2 X Slope (%)	2.1

N/A	Ramp inside XWalk1?	N/A	N/A	Ramp inside XWalk2?	N/A
	Road Slope (%)	3.8	N/A	Clear Space?	N/A
	Road X Slope (%)	5.5	N/A	Clear Space to XWalk (in)	N/A
N/A	Any Obstructions?	N/A	N/A	Storm Grate/Utility Hazard?	N/A
	Obstruction Type			Storm Grate/Utility Type	
		N/A			N/A
		Yes		Surface Condition? (G/P)	Good

Remove & Replace Curb Ramp With Two New Directional Ramps or Equivalent.
