# Access Compliance Report

## Public Rights-of-Way

### (Curb Ramps)

Intersection ID: 28112	Main Street: PROVIDENCE_RD	Cross Street: BELICOURT_DR	Location: NW
ADA ID: 2AC72E5EF19D	Ramp Type: Para	Initial Pass/Fail: Fail	Overall Compliance: No
Codes/Mitigation Info/Possible Solution		Field Measurements/Component Compliance

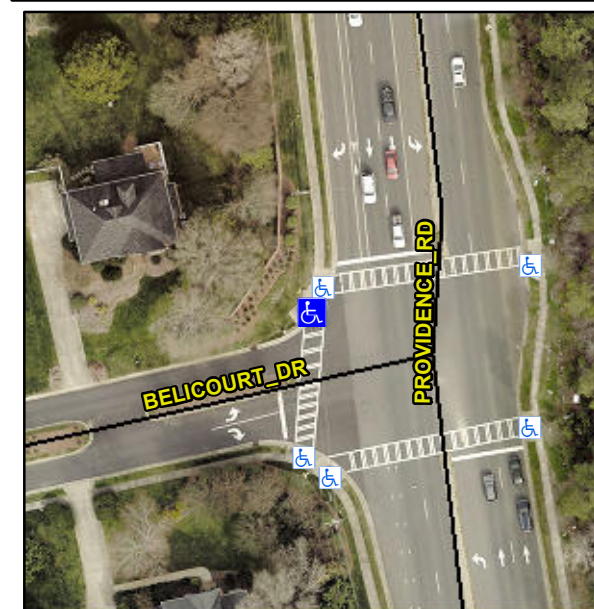
**LT RP < 5%**

**R304.5.3, R304.3.2**

Compliance	Description	Data	Compliance	Description	Data
N/A	Ramp Length LT (in)	58.0	N/A	Ramp Length RT (in)	59.0
Yes	Ramp Width LT (in)	59.5	Yes	Ramp Width RT (in)	60.0
Yes	Ramp Slope LT (%)	2.5	No	Ramp Slope RT (%)	10.4
No	Ramp XSlope LT (%)	3.0	Yes	Ramp XSlope RT (%)	2.0
N/A	Landing Length (in)	N/A	N/A	DWS Provided?	N/A
N/A	Landing Width (in)	N/A	N/A	DWS Contrast?	N/A
N/A	Landing Slope (%)	N/A	N/A	DWS Length (in)	N/A
N/A	Landing X Slope (%)	N/A	N/A	DWS Full Width?	N/A
N/A	Landing Curb? (Y/N)	N/A	N/A	DWS Offset (in)	N/A
N/A	Shared Landing?	N/A			
N/A	Gutter Ponding?	N/A	N/A	Gutter Slope (%)	N/A
N/A	Gutter Lip Ht (in)	N/A	N/A	Gutter X Slope (%)	N/A
N/A	Painted X Walk1?	Yes	N/A	Painted X Walk2?	N/A
	X Walk 1 Direction	To S		X Walk 2 Direction	N/A
N/A	X Walk 1 Width (in)	105.0	N/A	X Walk 2 Width (in)	N/A
	X Walk 1 Slope (%)	4.1		X Walk 2 Slope (%)	N/A
	X Walk 1 X Slope (%)	2.0		X Walk 2 X Slope (%)	N/A
N/A	Ramp inside XWalk1?	Yes	N/A	Ramp inside XWalk2?	N/A

Road Slope (%)	N/A	N/A	Clear Space?	N/A
	Road X Slope (%)	N/A	N/A	Clear Space to XWalk (in)	N/A
N/A	Any Obstructions?	N/A	N/A	Storm Grate/Utility Hazard?	N/A
	Obstruction Type			Storm Grate/Utility Type	
		N/A			N/A
			Yes	Surface Condition? (G/P)	Good
			N/A	Curb Slope (%)	17.4

**Remove & Replace Entire Ramp.**
