Access Compliance Report

Public Rights-of-Way

(Curb Ramps)

Intersection ID: 20507	Main Street: SARDIS_RD	Cross Street: BOYCE_RD	Location: SW
ADA ID: 2AD132400940	Ramp Type: Perp	Initial Pass/Fail: Fail	Overall Compliance: No
Severity Score: 8.75			
Codes/Mitigation Info/Possible Solution		Field Measurements/Component Compliance

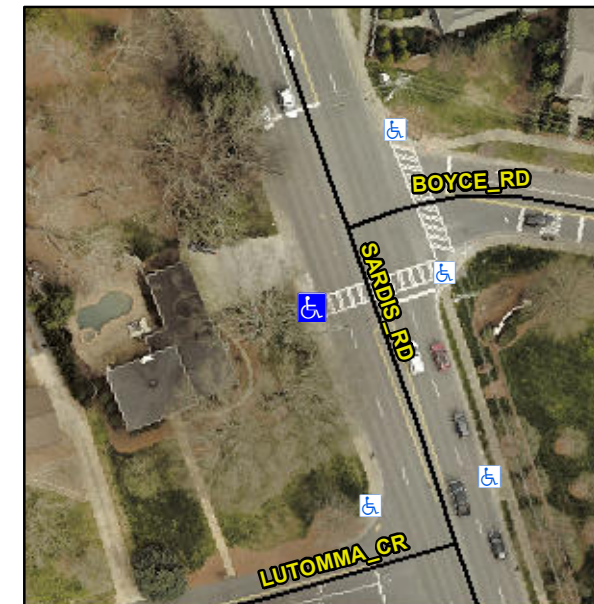
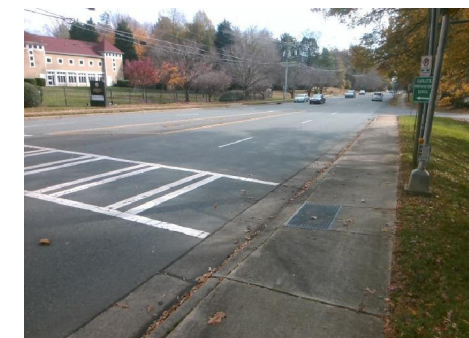
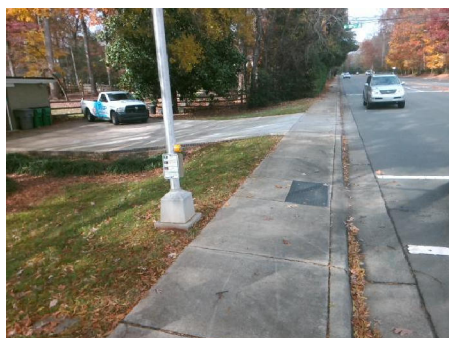
Not Found, R304.5.1

Compliance	Description	Data	Compliance	Description	Data
N/A	Ramp Length (in)	59.0	Yes	Ramp Slope (%)	8.2
No	Ramp Width (in)	46.0	Yes	Ramp XSlope (%)	1.8
N/A	Flare Type LT	N/A	N/A	Flare Type RT	N/A
N/A	Flare Slope LT (%)	N/A	N/A	Flare Slope RT (%)	N/A
N/A	Flare Traversable LT?	N/A	N/A	Flare Traversable RT?	N/A
N/A	Landing Length (in)	N/A	N/A	DWS Provided?	N/A
N/A	Landing Width (in)	N/A	N/A	DWS Contrast?	N/A
N/A	Landing Slope (%)	N/A	N/A	DWS Length (in)	N/A
N/A	Landing X Slope (%)	N/A	N/A	DWS Full Width?	N/A
N/A	Landing Curb? (Y/N)	N/A	N/A	DWS Offset (in)	N/A
N/A	Shared Landing?	N/A			
N/A	Gutter Ponding?	N/A	N/A	Gutter Slope (%)	N/A
N/A	Gutter Lip Ht (in)	N/A	N/A	Gutter X Slope (%)	N/A
N/A	Painted X Walk1?	Yes	N/A	Painted X Walk2?	N/A
	X Walk 1 Direction	To E		X Walk 2 Direction	N/A
N/A	X Walk 1 Width (in)	112.0	N/A	X Walk 2 Width (in)	N/A
	X Walk 1 Slope (%)	3.2		X Walk 2 Slope (%)	N/A
	X Walk 1 X Slope (%)	2.5		X Walk 2 X Slope (%)	N/A

N/A	Ramp inside XWalk1?	Yes	N/A	Ramp inside XWalk2?	N/A
	Road Slope (%)	N/A	N/A	Clear Space?	N/A
	Road X Slope (%)	N/A	N/A	Clear Space to XWalk (in)	N/A
N/A	Any Obstructions?	N/A	N/A	Storm Grate/Utility Hazard?	N/A
	Obstruction Type			Storm Grate/Utility Type	
		N/A			N/A
			Yes	Surface Condition? (G/P)	Good

Remove & Replace Entire Ramp.
