Access Compliance Report

Public Rights-of-Way

(Curb Ramps)

Intersection ID: 19071	Main Street: S_TRYON_ST	Cross Street: LAND_GRANT_RD	Location: SE
ADA ID: 2AD13EB1CCA6	Ramp Type: PerpDiag	Initial Pass/Fail: Fail	Overall Compliance: No
Severity Score: 12.5			
Codes/Mitigation Info/Possible Solution		Field Measurements/Component Compliance

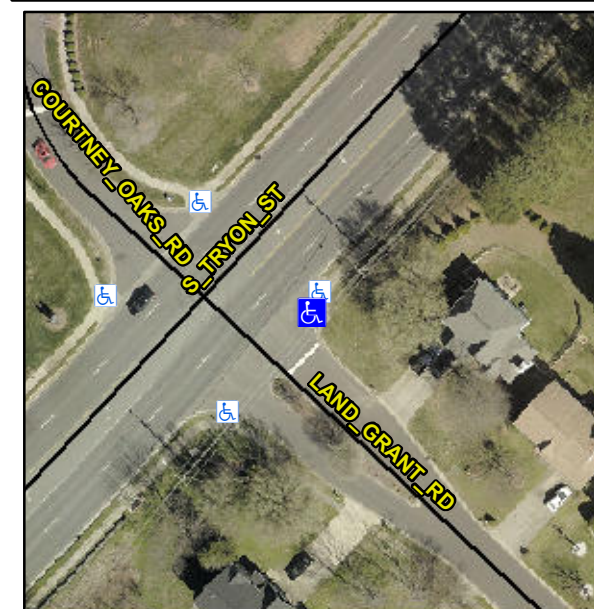
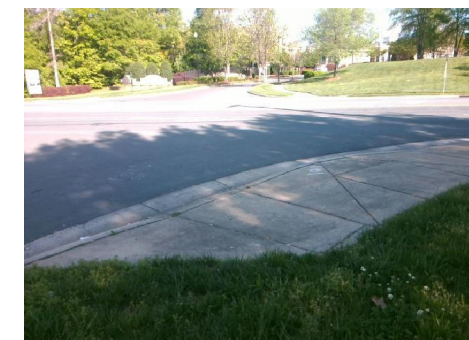
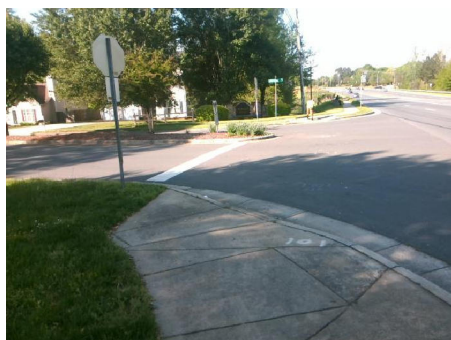
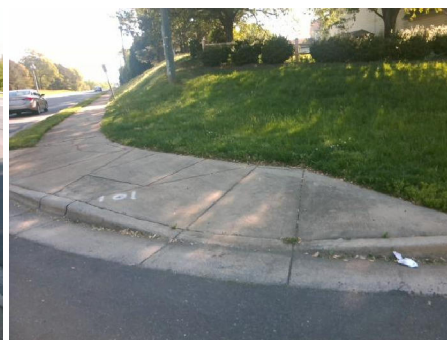
Compliance	Description	Data	Compliance	Description	Data
N/A	Ramp Length (in)	82.0	Yes	Ramp Slope (%)	6.4
Yes	Ramp Width (in)	48.0	No	Ramp XSlope (%)	6.6
N/A	Flare Type LT	N/A	N/A	Flare Type RT	N/A
N/A	Flare Slope LT (%)	N/A	N/A	Flare Slope RT (%)	N/A
N/A	Flare Traversable LT?	N/A	N/A	Flare Traversable RT?	N/A
N/A	Landing Length (in)	N/A	N/A	DWS Provided?	N/A
N/A	Landing Width (in)	N/A	N/A	DWS Contrast?	N/A
N/A	Landing Slope (%)	N/A	N/A	DWS Length (in)	N/A
N/A	Landing X Slope (%)	N/A	N/A	DWS Full Width?	N/A
N/A	Landing Curb? (Y/N)	N/A	N/A	DWS Offset (in)	N/A
N/A	Shared Landing?	N/A			
N/A	Gutter Ponding?	N/A	N/A	Gutter Slope (%)	N/A
N/A	Gutter Lip Ht (in)	N/A	N/A	Gutter X Slope (%)	N/A
N/A	Painted X Walk1?	No	N/A	Painted X Walk2?	No
	X Walk 1 Direction	To NW		X Walk 2 Direction	To SW
N/A	X Walk 1 Width (in)	N/A	N/A	X Walk 2 Width (in)	N/A
	X Walk 1 Slope (%)	6.8		X Walk 2 Slope (%)	2.1
	X Walk 1 X Slope (%)	0.7		X Walk 2 X Slope (%)	7.3

N/A	Ramp inside XWalk1?	N/A	N/A	Ramp inside XWalk2?	N/A
	Road Slope (%)	6.3	N/A	Clear Space?	N/A
	Road X Slope (%)	6.7	N/A	Clear Space to XWalk (in)	N/A
N/A	Any Obstructions?	N/A	N/A	Storm Grate/Utility Hazard?	N/A
	Obstruction Type			Storm Grate/Utility Type	
		N/A			N/A
			Yes	Surface Condition? (G/P)	Good

Remove & Replace Curb Ramp With Two New Directional Ramps or Equivalent.

R304.5.3
