# Access Compliance Report

## Public Rights-of-Way

### (Curb Ramps)

| Intersection ID: 15173 | Main Street: ALBEMARLE_RD | Cross Street: EXECUTIVE_CENTER_DR | Location: SW |

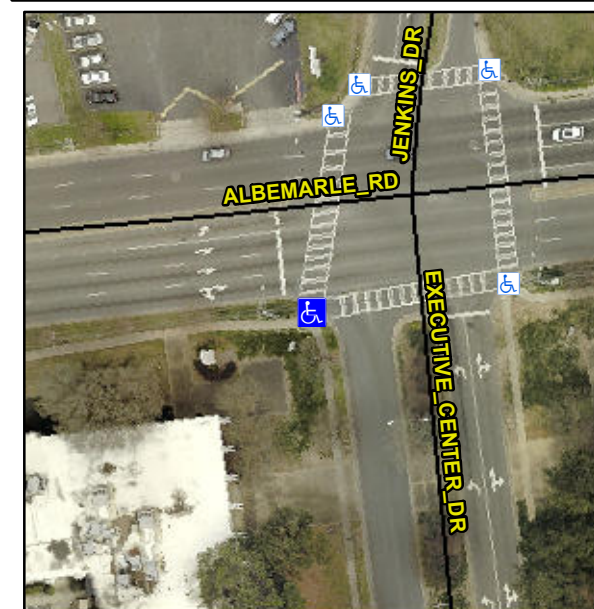
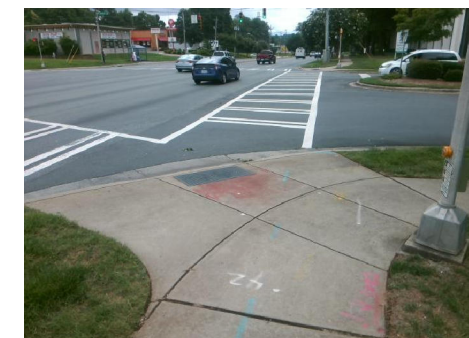
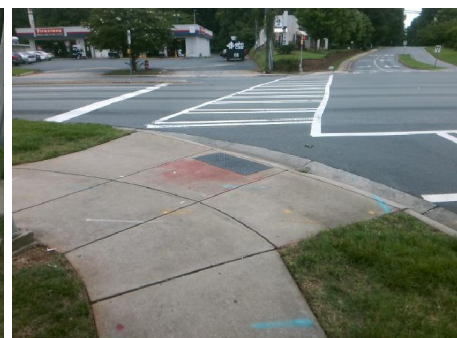
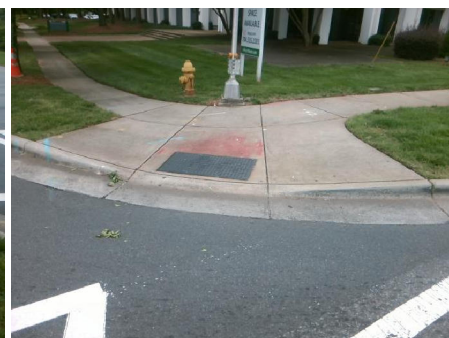
**Not Found, R304.5.3, R304.2.1, R305.2, R304.5.4**

| Compliance | Description | Data | Compliance | Description | Data |
|---|---|---|---|---|---|
| Yes | Ramp Width (in) | 52.5 | No | Ramp XSlope (%) | 4.4 |
| No | Landing Width (in) | 43.0 | Yes | DWS Contrast? | Yes |
| N/A | Landing Curb? (Y/N) | No | No | DWS Offset (in) | 4.0 |
| Yes | Gutter Ponding? | No | No | Gutter Slope (%) | 8.4 |

**Remove & Replace Curb Ramp With Two New Directional Ramps or Equivalent. Remove & Replace Gutter.**
