# Access Compliance Report

## Public Rights-of-Way

### (Curb Ramps)

| Intersection ID: 25187 | Main Street: BRIAR_RIDGE_DR | Cross Street: WEDDINGTON_RD | Location: NW |

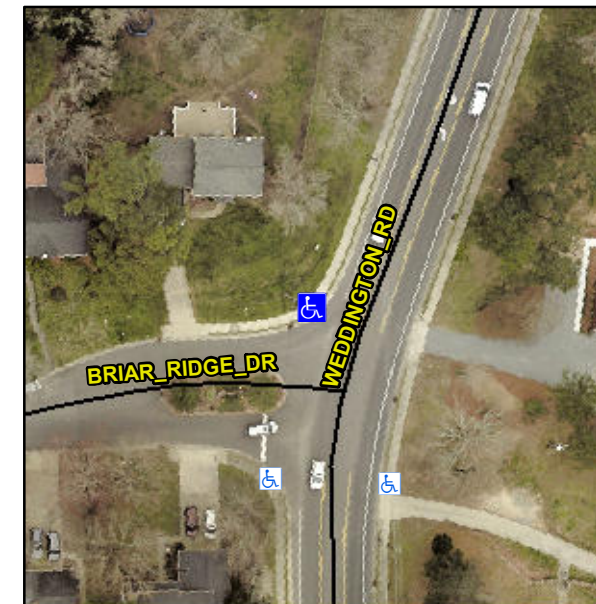
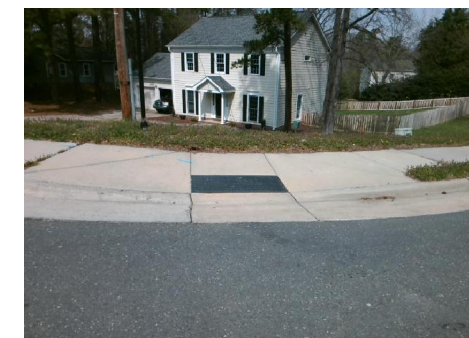
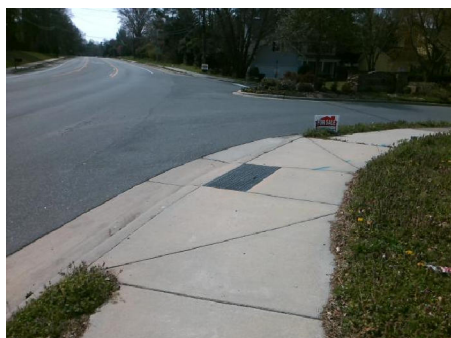
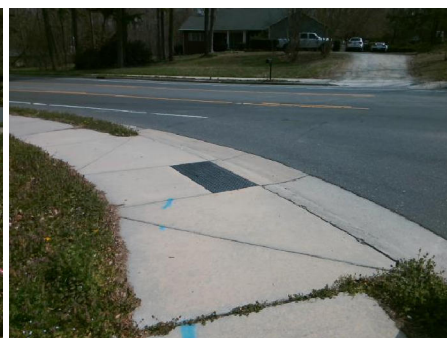
**Not Found, R304.5.3, R304.2.1, R304.2.2-Perp, R304.3.2-Para**

| Compliance | Description | Data | Compliance | Description | Data |
|---|---|---|---|---|---|
| N/A | Ramp Length (in) | 71.0 | Yes | Ramp Slope (%) | 7.3 |
| Yes | Ramp Width (in) | 48.0 | No | Ramp XSlope (%) | 3.6 |
| No | Landing Length (in) | N/A | Yes | DWS Provided? | Yes |
| No | Landing Width (in) | N/A | Yes | DWS Contrast? | Yes |
| No | Landing Slope (%) | N/A | Yes | DWS Length (in) | 24.4 |
| No | Landing X Slope (%) | N/A | Yes | DWS Full Width? | Yes |
| Yes | Gutter Lip Ht (in) | 0.0 | No | Gutter X Slope (%) | 4.0 |

Possible Solutions:

**Remove & Replace Curb Ramp With Two New Directional Ramps or Equivalent. Remove & Replace Gutter.**
