Access Compliance Report

Public Rights-of-Way

(Curb Ramps)

Intersection ID: 6911	Main Street: CINDY_LN	Cross Street: CINDY_PARK_DR	Location: NE
ADA ID: 2AE957C754EC	Ramp Type: Perp	Initial Pass/Fail: Fail	Overall Compliance: No
Severity Score: 8.75			
Codes/Mitigation Info/Possible Solution		Field Measurements/Component Compliance

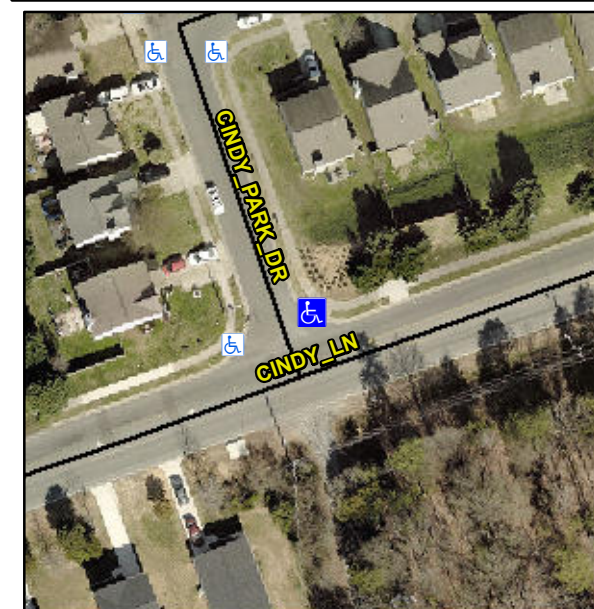
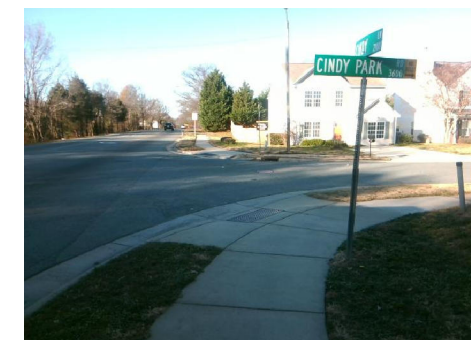
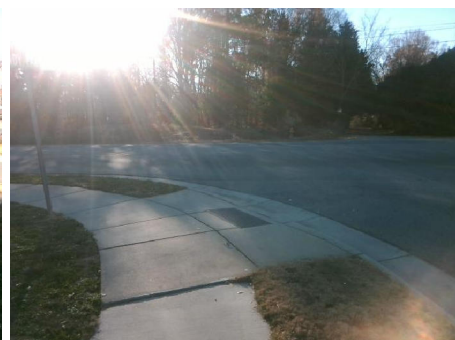
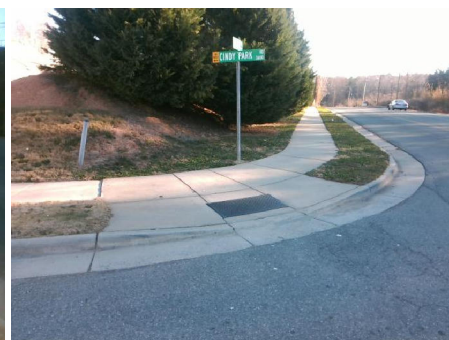
Not Found, R304.5.1

Compliance	Description	Data	Compliance	Description	Data
N/A	Ramp Length (in)	46.0	Yes	Ramp Slope (%)	7.0
No	Ramp Width (in)	41.0	Yes	Ramp XSlope (%)	1.9
N/A	Flare Type LT	N/A	N/A	Flare Type RT	N/A
N/A	Flare Slope LT (%)	N/A	N/A	Flare Slope RT (%)	N/A
N/A	Flare Traversable LT?	N/A	N/A	Flare Traversable RT?	N/A
N/A	Landing Length (in)	N/A	N/A	DWS Provided?	N/A
N/A	Landing Width (in)	N/A	N/A	DWS Contrast?	N/A
N/A	Landing Slope (%)	N/A	N/A	DWS Length (in)	N/A
N/A	Landing X Slope (%)	N/A	N/A	DWS Full Width?	N/A
N/A	Landing Curb? (Y/N)	N/A	N/A	DWS Offset (in)	N/A
N/A	Shared Landing?	N/A			
N/A	Gutter Ponding?	N/A	N/A	Gutter Slope (%)	N/A
N/A	Gutter Lip Ht (in)	N/A	N/A	Gutter X Slope (%)	N/A
N/A	Painted X Walk1?	No	N/A	Painted X Walk2?	N/A
	X Walk 1 Direction	To W		X Walk 2 Direction	N/A
N/A	X Walk 1 Width (in)	N/A	N/A	X Walk 2 Width (in)	N/A
	X Walk 1 Slope (%)	1.4		X Walk 2 Slope (%)	N/A
	X Walk 1 X Slope (%)	0.1		X Walk 2 X Slope (%)	N/A

Remove & Replace Entire Ramp.

Total Cost: \$ 1850.00
