Access Compliance Report

Public Rights-of-Way

(Curb Ramps)

Intersection ID: 8687	Main Street: MCDONALD_ST	Cross Street: REMINGTON_ST	Location: SW
ADA ID: 2AF2BF04C8B0	Ramp Type: BlendTrans1	Initial Pass/Fail: Pass	Overall Compliance: No
		Severity Score: 25

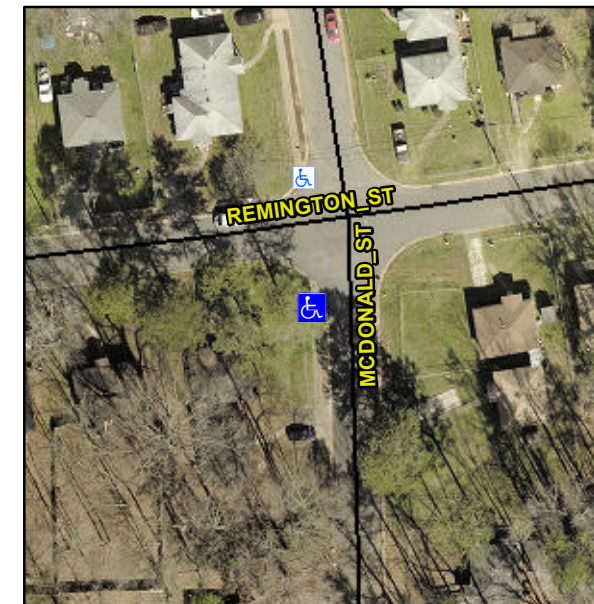
Not Found, R304.5.3, R305, R302.7.2

Compliance	Description	Data	Compliance	Description	Data
N/A	Ramp Length (in)	39.0	Yes	BlendTrans Slope (%)	1.7
Yes	Ramp Width (in)	113.0	Yes	BlendTrans XSlope (%)	2.0
N/A	Flare Type LT	Sloped	N/A	Flare Type RT	Sloped
N/A	Flare Slope LT (%)	4.6	N/A	Flare Slope RT (%)	1.2
N/A	Flare Traversable LT?	No	N/A	Flare Traversable RT?	No
Yes	Landing Length (in)	57.0	No	DWS Provided?	No
Yes	Landing Width (in)	57.0	N/A	DWS Contrast?	No
Yes	Landing Slope (%)	0.4	N/A	DWS Length (in)	N/A
No	Landing X Slope (%)	3.7	N/A	DWS Full Width?	No
N/A	Landing Curb? (Y/N)	No	N/A	DWS Offset (in)	N/A
N/A	Shared Landing?	No			
Yes	Gutter Ponding?	No	Yes	Gutter Slope (%)	0.2
No	Gutter Lip Ht (in)	1.0	No	Gutter X Slope (%)	2.7
N/A	Painted X Walk1?	No	N/A	Painted X Walk2?	N/A
	X Walk 1 Direction	To N		X Walk 2 Direction	N/A
	X Walk 1 Width (in)	N/A		X Walk 2 Width (in)	N/A
	X Walk 1 Slope (%)	2.2		X Walk 2 Slope (%)	N/A
	X Walk 1 X Slope (%)	1.7		X Walk 2 X Slope (%)	N/A

N/A	Ramp inside XWalk1?	N/A	N/A	Ramp inside XWalk2?	N/A
	Road Slope (%)	1.7		Clear Space?	Yes
	Road X Slope (%)	2.2	N/A	Clear Space to XWalk (in)	N/A
Yes	Any Obstructions?	No	Yes	Storm Grate/Utility Hazard?	No
	Obstruction Type			Storm Grate/Utility Type	
		N/A			N/A
			Yes	Surface Condition? (G/P)	Good
			No	Curb Slope (%)	8.7

Remove & Replace Curb Ramp With Two New Directional Ramps or Equivalent. Remove & Replace Gutter.
