Access Compliance Report Public Rights-of-Way (Curb Ramps)

Intersection ID: 52908 Main Street: FLAT BRANCH CLOSE RD Cross Street: CLEMS CROSSING DR Location: NE **Overall Compliance: No Severity Score:** 1.25 ADA ID: 2AF3A485D3B4 Ramp Type: BlendTrans1 Initial Pass/Fail: Fail

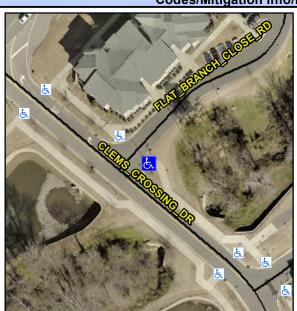
FLAT BRANCH CLOSE RD Street 1 Name Stop Condition-Street 1 Street 2 Name Stop Condition-Street 2

Remove & Replace Curb Ramp With Two New Directional Ramps or Equivalent.

R304.5.3
