# Access Compliance Report

## Public Rights-of-Way

### (Curb Ramps)

| Intersection ID: 48988 | Main Street: AVONCLIFF_DR | Cross Street: SMITHFIELD_DR | Location: NW |

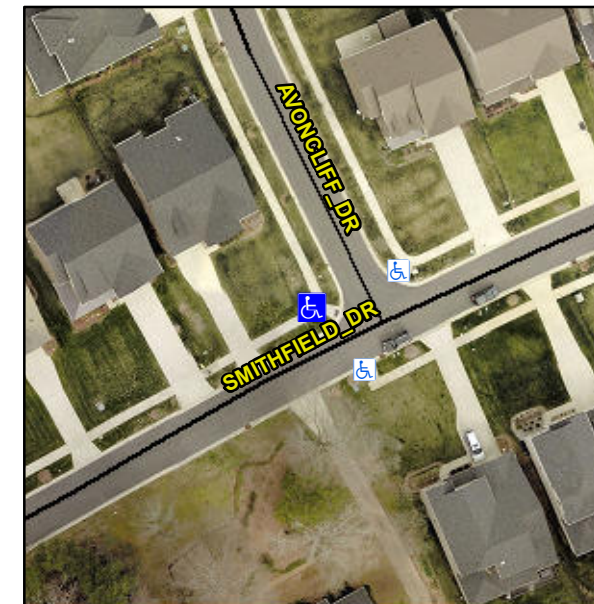
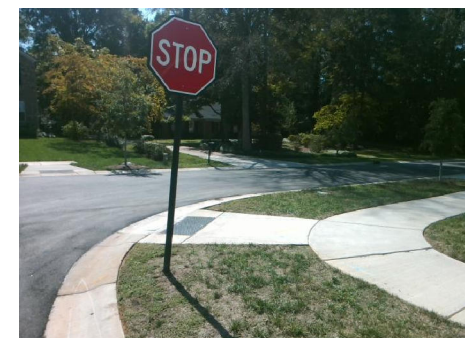
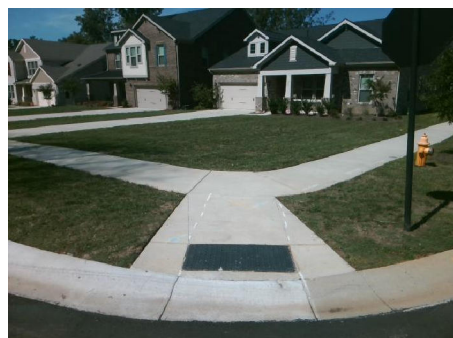
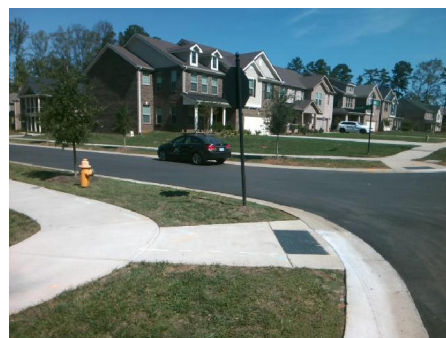
| ADA ID: 2B02710415D5 | Ramp Type: BlendTrans1 | Initial Pass/Fail: Pass | Overall Compliance: No |

| Severity Score: 5 | | | |

**Not Found, R304.5.3, R305.2, R304.5.4**

| Compliance | Description | Data | Compliance | Description | Data |
|---|---|---|---|---|---|
| No | Landing X Slope (%) | 2.1 | Yes | DWS Full Width? | Yes |
| N/A | Landing Curb? (Y/N) | No | No | DWS Offset (in) | 5.5 |
| Yes | Gutter Ponding? | No | No | Gutter Slope (%) | 11.4 |

**Remove & Replace Curb Ramp With Two New Directional Ramps or Equivalent. Remove & Replace Gutter.**

Total Cost: \$ 3950.00
