# Access Compliance Report

## Public Rights-of-Way

### (Curb Ramps)

Intersection ID: 27340	Main Street: SHINING ROCK CT	Cross Street: STONEPATH LN	Location: E
ADA ID: 2B08BE9DAD04	Ramp Type: PerpDiag	Initial Pass/Fail: Fail	Overall Compliance: No
		Severity Score: 12.5

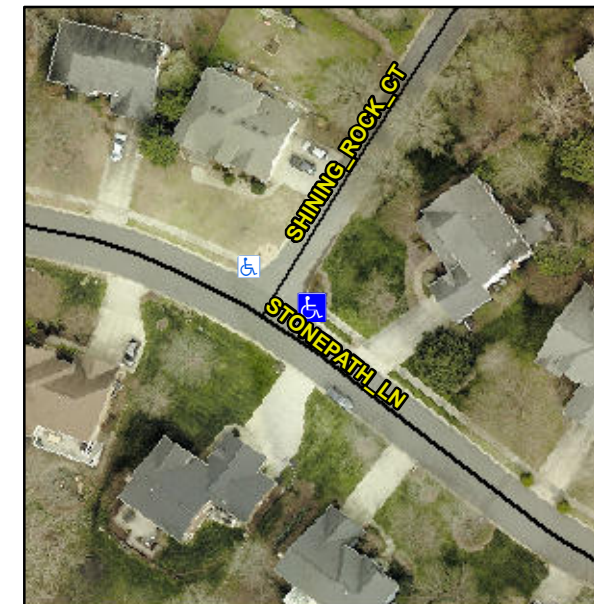
**Not Found, R304.2.2**

Compliance	Description	Data	Compliance	Description	Data
N/A	Ramp Length (in)	56.0	No	Ramp Slope (%)	10.6
Yes	Ramp Width (in)	48.0	Yes	Ramp XSlope (%)	1.5
N/A	Flare Type LT	N/A	N/A	Flare Type RT	N/A
N/A	Flare Slope LT (%)	N/A	N/A	Flare Slope RT (%)	N/A
N/A	Flare Traversable LT?	N/A	N/A	Flare Traversable RT?	N/A
N/A	Landing Length (in)	N/A	N/A	DWS Provided?	N/A
N/A	Landing Width (in)	N/A	N/A	DWS Contrast?	N/A
N/A	Landing Slope (%)	N/A	N/A	DWS Length (in)	N/A
N/A	Landing X Slope (%)	N/A	N/A	DWS Full Width?	N/A
N/A	Landing Curb? (Y/N)	N/A	N/A	DWS Offset (in)	N/A
N/A	Shared Landing?	N/A			
N/A	Gutter Ponding?	N/A	N/A	Gutter Slope (%)	N/A
N/A	Gutter Lip Ht (in)	N/A	N/A	Gutter X Slope (%)	N/A
N/A	Painted X Walk1?	No	N/A	Painted X Walk2?	No
	X Walk 1 Direction	To NW		X Walk 2 Direction	To SW
N/A	X Walk 1 Width (in)	N/A	N/A	X Walk 2 Width (in)	N/A
	X Walk 1 Slope (%)	0.1		X Walk 2 Slope (%)	2.6
	X Walk 1 X Slope (%)	2.6		X Walk 2 X Slope (%)	0.9

N/A	Ramp inside XWalk1?	N/A	N/A	Ramp inside XWalk2?	N/A
	Road Slope (%)	2.1	N/A	Clear Space?	N/A
	Road X Slope (%)	2.6	N/A	Clear Space to XWalk (in)	N/A
N/A	Any Obstructions?	N/A	N/A	Storm Grate/Utility Hazard?	N/A
	Obstruction Type			Storm Grate/Utility Type	
		N/A			N/A
			Yes	Surface Condition? (G/P)	Good

**Remove & Replace Curb Ramp With Two New Directional Ramps or Equivalent.**

Total Cost: \$ 3200.00
