Access Compliance Report

Public Rights-of-Way

(Curb Ramps)

Intersection ID: N/A	Main Street: S_BREVARD_ST	Cross Street: E_STONEWALL_ST	Location: E
ADA ID: 2B0D207E9356	Ramp Type: Perp	Initial Pass/Fail: Pass	Overall Compliance: No
Severity Score: 2.75			
Codes/Mitigation Info/Possible Solution		Field Measurements/Component Compliance

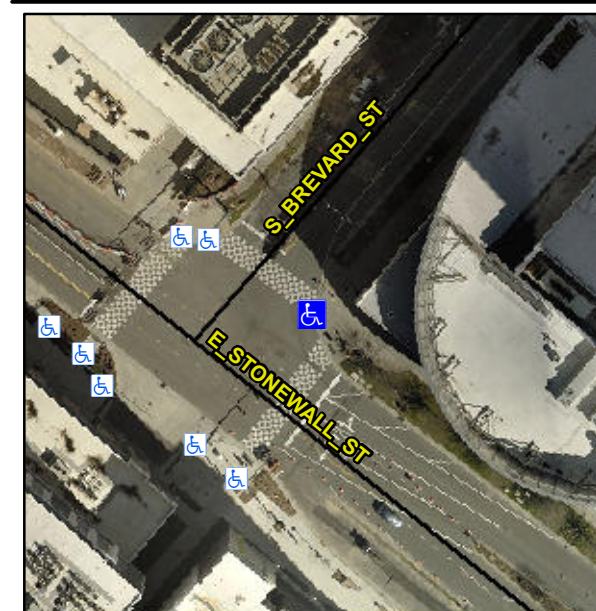
Compliance	Description	Data	Compliance	Description	Data
N/A	Ramp Length (in)	97.0	Yes	Ramp Slope (%)	7.0
Yes	Ramp Width (in)	57.0	Yes	Ramp XSlope (%)	2.3
N/A	Flare Type LT	Sloped	N/A	Flare Type RT	N/A
N/A	Flare Slope LT (%)	10.2	Yes	Flare Slope RT (%)	5.9
N/A	Flare Traversable LT?	Yes	N/A	Flare Traversable RT?	Yes
Yes	Landing Length (in)	48.0	Yes	DWS Provided?	Yes
Yes	Landing Width (in)	48.0	Yes	DWS Contrast?	Yes
No	Landing Slope (%)	3.4	Yes	DWS Length (in)	24.0
Yes	Landing X Slope (%)	0.7	Yes	DWS Full Width?	Yes
N/A	Landing Curb? (Y/N)	No	Yes	DWS Offset (in)	1.0
N/A	Shared Landing?	No			
Yes	Gutter Ponding?	No	Yes	Gutter Slope (%)	0.4
Yes	Gutter Lip Ht (in)	0.0	Yes	Gutter X Slope (%)	0.4
N/A	Painted X Walk1?	Yes	N/A	Painted X Walk2?	N/A
	X Walk 1 Direction	To NW		X Walk 2 Direction	N/A
N/A	X Walk 1 Width (in)	144.0	N/A	X Walk 2 Width (in)	N/A
	X Walk 1 Slope (%)	4.2		X Walk 2 Slope (%)	N/A
	X Walk 1 X Slope (%)	4.3		X Walk 2 X Slope (%)	N/A

Yes	Ramp inside XWalk1?	Yes	N/A	Ramp inside XWalk2?	N/A
	Road Slope (%)	N/A	N/A	Clear Space?	Yes
	Road X Slope (%)	N/A	N/A	Clear Space to XWalk (in)	N/A
Yes	Any Obstructions?	No	Yes	Storm Grate/Utility Hazard?	No
	Obstruction Type			Storm Grate/Utility Type	
		N/A			N/A
			Yes	Surface Condition? (G/P)	Good

Possible Solutions:

Remove & Replace Entire Ramp.
