Access Compliance Report

Public Rights-of-Way

(Curb Ramps)

Intersection ID: 2927	Main Street: DOWNFIELD_WOOD_DR	Cross Street: RIDGEFIELD_DR	Location: NE
ADA ID: 2B0D8FAC5960	Ramp Type: Perp	Initial Pass/Fail: Fail	Overall Compliance: No
Severity Score: 8.75			
Codes/Mitigation Info/Possible Solution		Field Measurements/Component Compliance

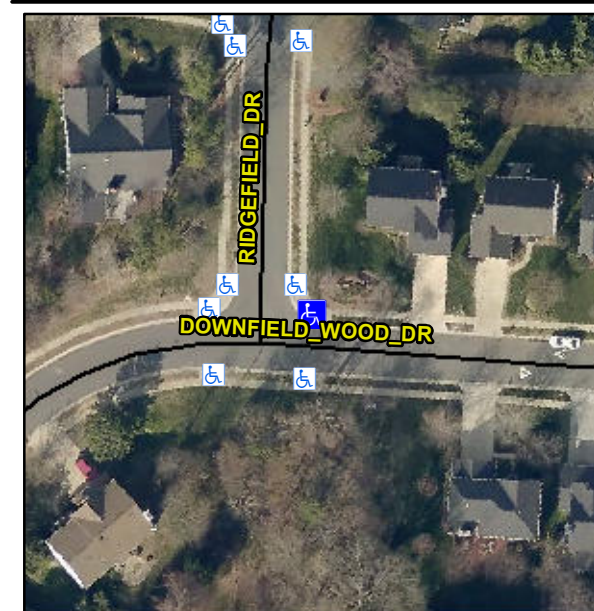
Not Found, R304.5.1

Compliance	Description	Data	Compliance	Description	Data
N/A	Ramp Length (in)	49.0	Yes	Ramp Slope (%)	7.0
No	Ramp Width (in)	38.0	Yes	Ramp XSlope (%)	0.9
N/A	Flare Type LT	N/A	N/A	Flare Type RT	N/A
N/A	Flare Slope LT (%)	N/A	N/A	Flare Slope RT (%)	N/A
N/A	Flare Traversable LT?	N/A	N/A	Flare Traversable RT?	N/A
N/A	Landing Length (in)	N/A	N/A	DWS Provided?	N/A
N/A	Landing Width (in)	N/A	N/A	DWS Contrast?	N/A
N/A	Landing Slope (%)	N/A	N/A	DWS Length (in)	N/A
N/A	Landing X Slope (%)	N/A	N/A	DWS Full Width?	N/A
N/A	Landing Curb? (Y/N)	N/A	N/A	DWS Offset (in)	N/A
N/A	Shared Landing?	N/A			
N/A	Gutter Ponding?	N/A	N/A	Gutter Slope (%)	N/A
N/A	Gutter Lip Ht (in)	N/A	N/A	Gutter X Slope (%)	N/A
N/A	Painted X Walk1?	No	N/A	Painted X Walk2?	N/A
	X Walk 1 Direction	To S		X Walk 2 Direction	N/A
N/A	X Walk 1 Width (in)	N/A	N/A	X Walk 2 Width (in)	N/A
	X Walk 1 Slope (%)	3.4		X Walk 2 Slope (%)	N/A
	X Walk 1 X Slope (%)	1.8		X Walk 2 X Slope (%)	N/A

N/A	Ramp inside XWalk1?	N/A	N/A	Ramp inside XWalk2?	N/A
	Road Slope (%)	N/A	N/A	Clear Space?	N/A
	Road X Slope (%)	N/A	N/A	Clear Space to XWalk (in)	N/A
N/A	Any Obstructions?	N/A	N/A	Storm Grate/Utility Hazard?	N/A
	Obstruction Type			Storm Grate/Utility Type	
		N/A			N/A
			Yes	Surface Condition? (G/P)	Good

Possible Solutions:

Remove & Replace Entire Ramp.
