Access Compliance Report

Public Rights-of-Way

(Curb Ramps)

Intersection ID: 50606	Main Street: DENBUR_DR	Cross Street: BENDING_BRANCH_RD	Location:	N
ADA ID: 2B1153962084	Ramp Type: Perp	Initial Pass/Fail: Fail	Overall Compliance: No	Severity Score: 12.5

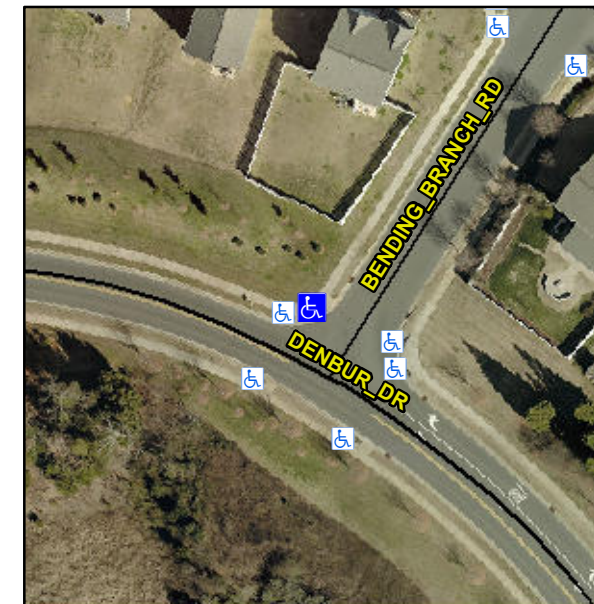
Compliance	Description	Data	Compliance	Description	Data
N/A	Ramp Length (in)	47.0	Yes	Ramp Slope (%)	6.5
Yes	Ramp Width (in)	48.0	No	Ramp XSlope (%)	5.9
N/A	Flare Type LT	N/A	N/A	Flare Type RT	N/A
N/A	Flare Slope LT (%)	N/A	N/A	Flare Slope RT (%)	N/A
N/A	Flare Traversable LT?	N/A	N/A	Flare Traversable RT?	N/A
N/A	Landing Length (in)	N/A	N/A	DWS Provided?	N/A
N/A	Landing Width (in)	N/A	N/A	DWS Contrast?	N/A
N/A	Landing Slope (%)	N/A	N/A	DWS Length (in)	N/A
N/A	Landing X Slope (%)	N/A	N/A	DWS Full Width?	N/A
N/A	Landing Curb? (Y/N)	N/A	N/A	DWS Offset (in)	N/A
N/A	Shared Landing?	N/A			
N/A	Gutter Ponding?	N/A	N/A	Gutter Slope (%)	N/A
N/A	Gutter Lip Ht (in)	N/A	N/A	Gutter X Slope (%)	N/A
N/A	Painted X Walk1?	No	N/A	Painted X Walk2?	N/A
	X Walk 1 Direction	To SE		X Walk 2 Direction	N/A
N/A	X Walk 1 Width (in)	N/A	N/A	X Walk 2 Width (in)	N/A
	X Walk 1 Slope (%)	4.1		X Walk 2 Slope (%)	N/A
	X Walk 1 X Slope (%)	3.9		X Walk 2 X Slope (%)	N/A

N/A	Ramp inside XWalk1?	N/A	N/A	Ramp inside XWalk2?	N/A
	Road Slope (%)	N/A	N/A	Clear Space?	N/A
	Road X Slope (%)	N/A	N/A	Clear Space to XWalk (in)	N/A
N/A	Any Obstructions?	N/A	N/A	Storm Grate/Utility Hazard?	N/A
	Obstruction Type			Storm Grate/Utility Type	
		N/A			N/A
			Yes	Surface Condition? (G/P)	Good

Possible Solutions:

Remove & Replace Entire Ramp.

Total Cost: \$ 1850.00
