Access Compliance Report

Public Rights-of-Way

(Curb Ramps)

Intersection ID: 14455		Main Street: EAST_BV		Cross Street: WINTHROP_AV		Location: NE			
ADA ID: 2B15C8B94CEB		Ramp Type: Directional1		Initial Pass/Fail: Fail		Overall Compliance: No		Severity Score: 12.5	
Codes/Mitigation Info/Possible Solution				Field Measurements/Component Compliance					
<div>

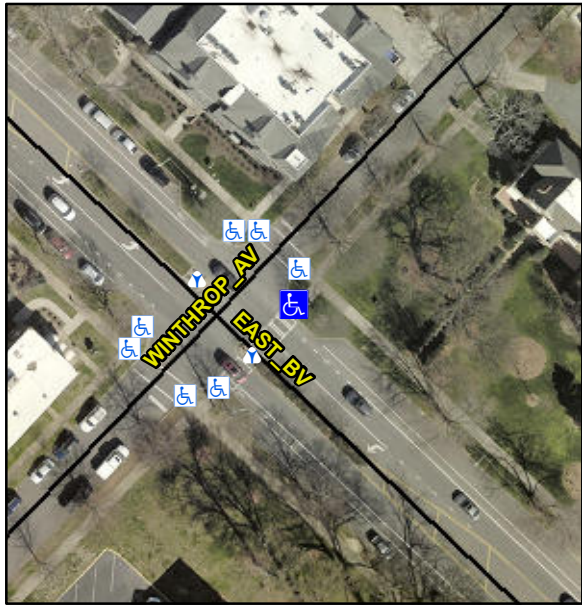
</div> <div>Street 1 NameEAST BV</div> <div>Stop Condition-Street 1None</div> <div>Street 2 NameN/A</div> <div>Stop Condition-Street 2N/A</div> <div>Possible Solutions: Remove & Replace Entire Ramp.</div> <div>Surveyor Notes: N/A</div> <div>PROW/ADA: R304.2.2</div> <div>Total Cost:\$ 1600.00</div>				Compliance	Description	Data	Compliance	Description	Data
				N/A	Ramp Length (in)	57.0	N/A	Grade Break?	N/A
				Yes	Ramp Width (in)	72.0	N/A	Grade Break Slope (%)	0.0
				No	Ramp Slope (%)	8.4	N/A	Grade Break XSlope (%)	0.0
				Yes	Ramp XSlope (%)	0.9			
				N/A	Flare Type LT	N/A	N/A	Flare Type RT	N/A
				N/A	Flare Slope LT (%)	N/A	N/A	Flare Slope RT (%)	0.0

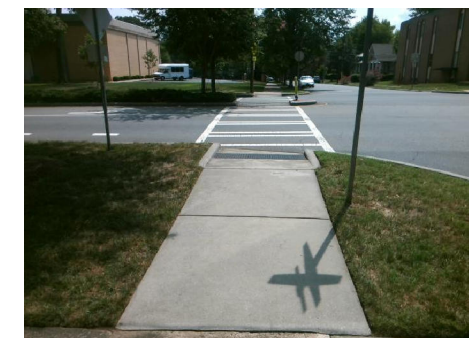
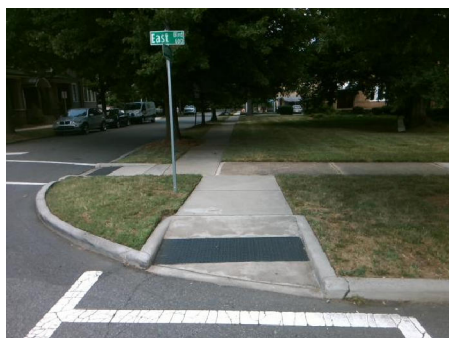
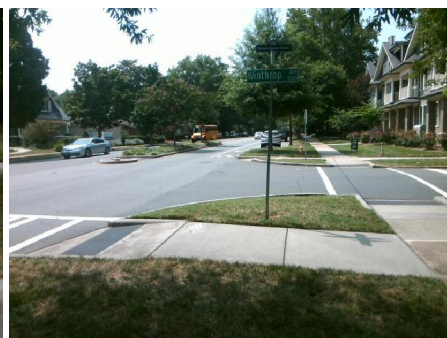
N/A	Flare Traversable LT?	N/A	N/A	Flare Traversable RT?	N/A
				N/A	Landing Length (in)	0.0	N/A	DWS Provided?	N/A
				N/A	Landing Width (in)	0.0	N/A	DWS Contrast?	N/A
				N/A	Landing Slope (%)	0.0	N/A	DWS Length (in)	N/A
				N/A	Landing X Slope (%)	0.0	N/A	DWS Full Width?	N/A
				N/A	Landing Curb? (Y/N)	N/A	N/A	DWS Offset LT (in)	N/A
				N/A	Shared Landing?	N/A	N/A	DWS Offset RT (in)	N/A
				N/A	Gutter Ponding?	0.0	N/A	Gutter Slope (%)	N/A
				N/A	Gutter Lip Ht (in)	0.0	N/A	Gutter X Slope (%)	N/A
				N/A	Painted X Walk1?	Yes		Road Slope (%)	2.4
					X Walk 1 Direction	To SW		Road X Slope (%)	2.4
					X Walk 1 Width (in)	112.0		Clear Space?	N/A
					X Walk 1 Slope (%)	2.4	N/A	Clear Space to XWalk (in)	N/A
					X Walk 1 X Slope (%)	2.4	N/A	Storm Grate/Utility Hazard?	N/A
				N/A	Ramp inside XWalk1?	Yes		Storm Grate/Utility Type	
				N/A	Any Obstructions?	N/A			N/A
					Obstruction Type		Yes	Surface Condition? (G/P)	Good

N/A	Curb Slope (%)	5.1
