Access Compliance Report

Public Rights-of-Way

(Curb Ramps)

Intersection ID: 3973	Main Street: MALLARD_CREEK_RD	Cross Street: W_MALLARD_CREEK_CHURCH_RD	Location: NW
ADA ID: 2B20BABDF893	Ramp Type: Para	Initial Pass/Fail: Fail	Overall Compliance: No
		Severity Score: 1.25

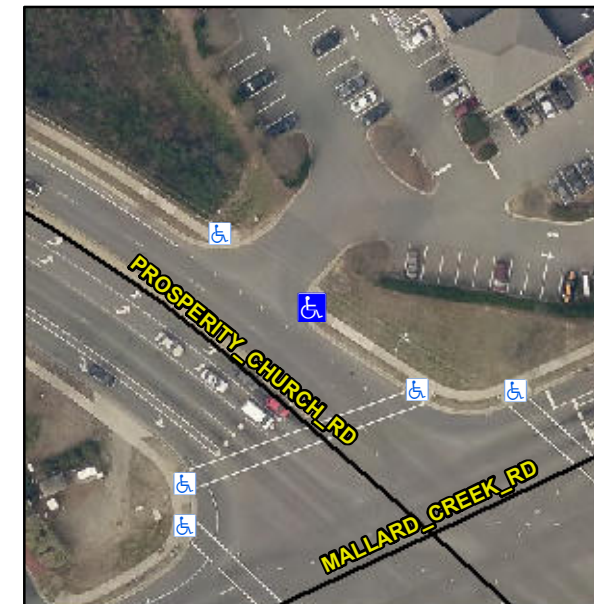
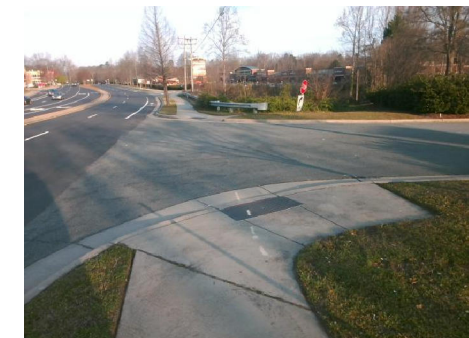
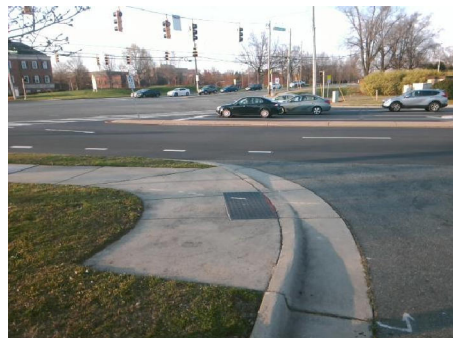
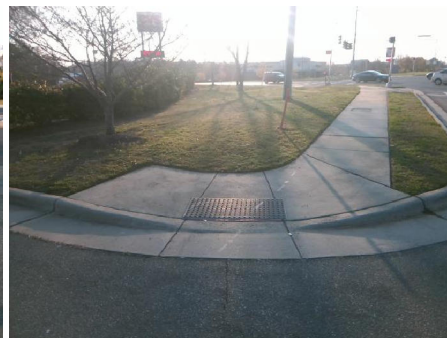
Compliance	Description	Data	Compliance	Description	Data
N/A	Ramp Length LT (in)	54.0	N/A	Ramp Length RT (in)	45.0
Yes	Ramp Width LT (in)	71.0	Yes	Ramp Width RT (in)	76.0
Yes	Ramp Slope LT (%)	3.0	Yes	Ramp Slope RT (%)	5.4
No	Ramp XSlope LT (%)	2.5	No	Ramp XSlope RT (%)	2.8
N/A	Landing Length (in)	N/A	N/A	DWS Provided?	N/A
N/A	Landing Width (in)	N/A	N/A	DWS Contrast?	N/A
N/A	Landing Slope (%)	N/A	N/A	DWS Length (in)	N/A
N/A	Landing X Slope (%)	N/A	N/A	DWS Full Width?	N/A
N/A	Landing Curb? (Y/N)	N/A	N/A	DWS Offset (in)	N/A
N/A	Shared Landing?	N/A			
N/A	Gutter Ponding?	N/A	N/A	Gutter Slope (%)	N/A
N/A	Gutter Lip Ht (in)	N/A	N/A	Gutter X Slope (%)	N/A
N/A	Painted X Walk1?	No	N/A	Painted X Walk2?	N/A
	X Walk 1 Direction	To NW		X Walk 2 Direction	N/A
N/A	X Walk 1 Width (in)	N/A	N/A	X Walk 2 Width (in)	N/A
	X Walk 1 Slope (%)	1.8		X Walk 2 Slope (%)	N/A
	X Walk 1 X Slope (%)	1.4		X Walk 2 X Slope (%)	N/A
N/A	Ramp inside XWalk1?	N/A	N/A	Ramp inside XWalk2?	N/A

Road Slope (%)	N/A	N/A	Clear Space?	N/A
	Road X Slope (%)	N/A	N/A	Clear Space to XWalk (in)	N/A
N/A	Any Obstructions?	N/A	N/A	Storm Grate/Utility Hazard?	N/A
	Obstruction Type			Storm Grate/Utility Type	
		N/A			N/A
			Yes	Surface Condition? (G/P)	Good
			N/A	Curb Slope (%)	5.6

Remove & Replace Entire Ramp.

R304.5.3

\$ 1600.00
