# Access Compliance Report

## Public Rights-of-Way

### (Curb Ramps)

| Intersection ID: 47614 | Main Street: WYALONG_DR | Cross Street: MACQUARIE_LN | Location: NW |

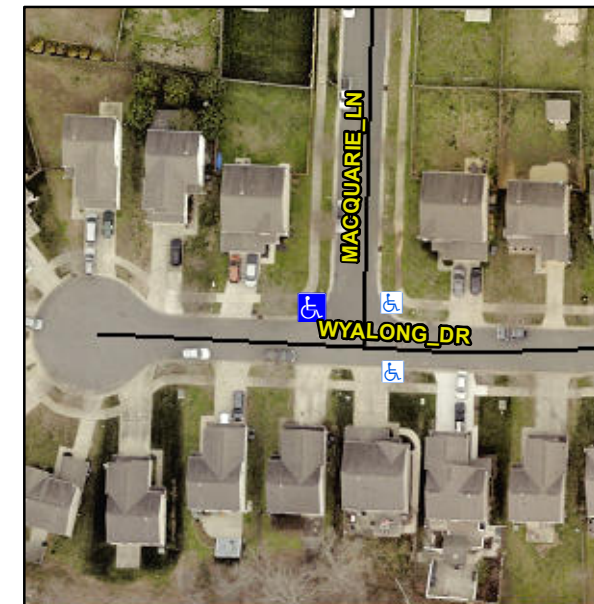
**Not Found, R304.5.1, R304.5.3**

| Compliance | Description | Data | Compliance | Description | Data |
|---|---|---|---|---|---|
| No | Ramp Width (in) | 46.5 | No | BlendTrans XSlope (%) | 3.5 |

**Remove & Replace Curb Ramp With Two New Directional Ramps or Equivalent.**
