Access Compliance Report

Public Rights-of-Way

(Curb Ramps)

Intersection ID: 10027508	Main Street: GRANDIFLORA_DR	Cross Street: N/A	Location: S
ADA ID: 2B24AEE8DEED	Ramp Type: PerpDiag	Initial Pass/Fail: Fail	Overall Compliance: No
Severity Score: 21.25			
Codes/Mitigation Info/Possible Solution		Field Measurements/Component Compliance

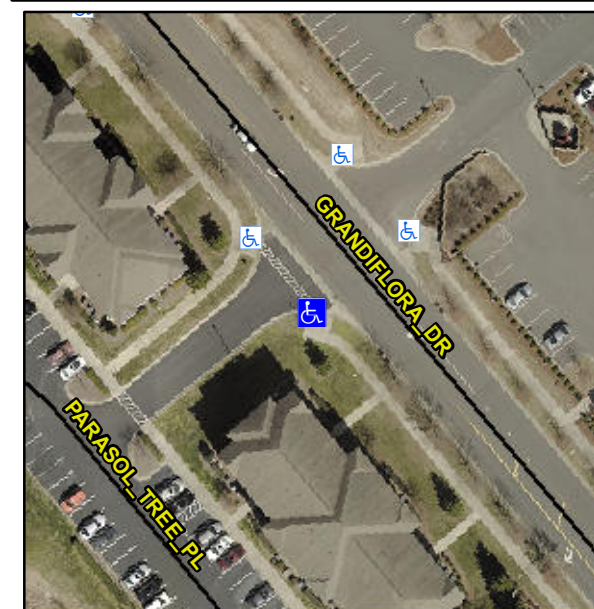
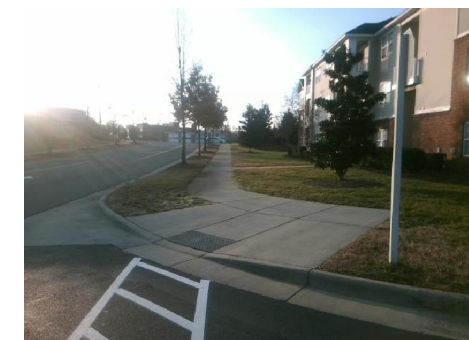
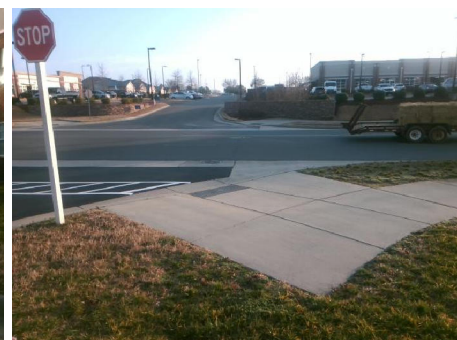
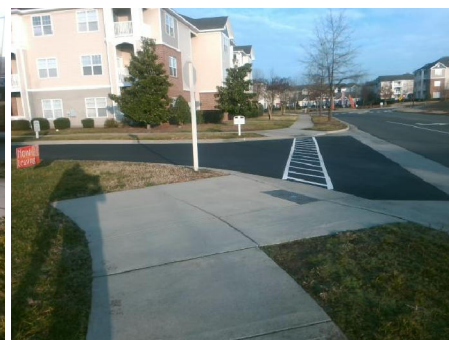
Compliance	Description	Data	Compliance	Description	Data
N/A	Ramp Length (in)	93.0	No	Ramp Slope (%)	8.9
No	Ramp Width (in)	47.0	Yes	Ramp XSlope (%)	2.0
N/A	Flare Type LT	N/A	N/A	Flare Type RT	N/A
N/A	Flare Slope LT (%)	N/A	N/A	Flare Slope RT (%)	N/A
N/A	Flare Traversable LT?	N/A	N/A	Flare Traversable RT?	N/A
N/A	Landing Length (in)	N/A	N/A	DWS Provided?	N/A
N/A	Landing Width (in)	N/A	N/A	DWS Contrast?	N/A
N/A	Landing Slope (%)	N/A	N/A	DWS Length (in)	N/A
N/A	Landing X Slope (%)	N/A	N/A	DWS Full Width?	N/A
N/A	Landing Curb? (Y/N)	N/A	N/A	DWS Offset (in)	N/A
N/A	Shared Landing?	N/A			
N/A	Gutter Ponding?	N/A	N/A	Gutter Slope (%)	N/A
N/A	Gutter Lip Ht (in)	N/A	N/A	Gutter X Slope (%)	N/A
N/A	Painted X Walk1?	No	N/A	Painted X Walk2?	Yes
	X Walk 1 Direction	To E		X Walk 2 Direction	To N
N/A	X Walk 1 Width (in)	N/A	N/A	X Walk 2 Width (in)	37.0
	X Walk 1 Slope (%)	2.7		X Walk 2 Slope (%)	1.2
	X Walk 1 X Slope (%)	0.3		X Walk 2 X Slope (%)	1.8

N/A	Ramp inside XWalk1?	N/A	N/A	Ramp inside XWalk2?	Yes
	Road Slope (%)	2.0	N/A	Clear Space?	N/A
	Road X Slope (%)	1.6	N/A	Clear Space to XWalk (in)	N/A
N/A	Any Obstructions?	N/A	N/A	Storm Grate/Utility Hazard?	N/A
	Obstruction Type			Storm Grate/Utility Type	
		N/A			N/A
		Yes		Surface Condition? (G/P)	Good

Remove & Replace Curb Ramp With Two New Directional Ramps or Equivalent.

R304.5.1, R304.2.2
