# Access Compliance Report

## Public Rights-of-Way

### (Curb Ramps)

| Intersection ID: 10015016 | Main Street: WILORA_LAKE_RD | Cross Street: N/A | Location: NW |

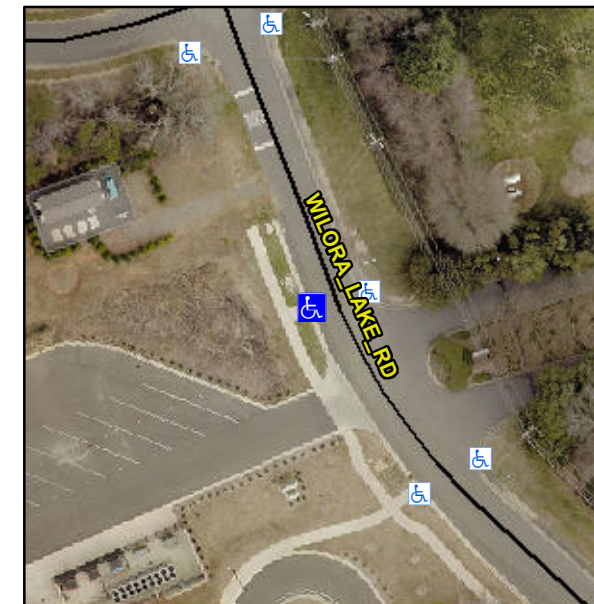
| ADA ID: 2B250DCD5DD5 | Ramp Type: Perp | Initial Pass/Fail: Pass | Overall Compliance: No |

| Compliance | Description | Data | Compliance | Description | Data |
|---|---|---|---|---|---|
| Yes | Landing X Slope (%) | 0.0 | No | DWS Full Width? | No |

**Remove & Replace Detectable Warning System.**

**R305.1.4**

**\$ 800.00**
