# Access Compliance Report

## Public Rights-of-Way

### (Curb Ramps)

Intersection ID: 12012	Main Street: PARSON_ST	Cross Street: KENNON_ST	Location: W
ADA ID: 2B2BB5E8927E	Ramp Type: Perp	Initial Pass/Fail: Fail	Overall Compliance: No
Severity Score: 48.75			
Codes/Mitigation Info/Possible Solution		Field Measurements/Component Compliance

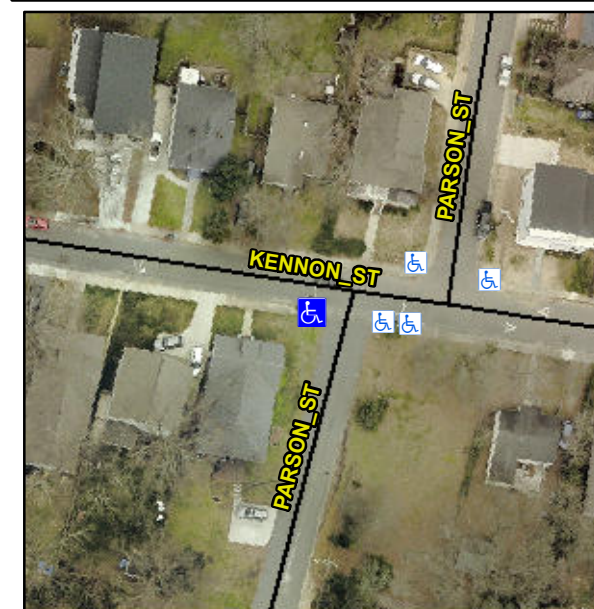
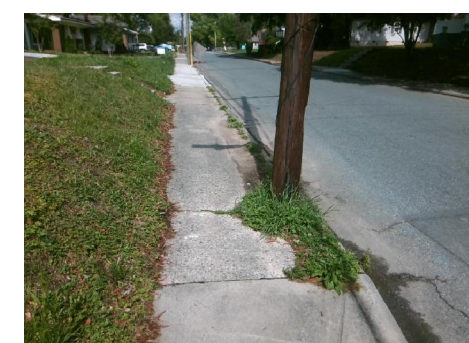
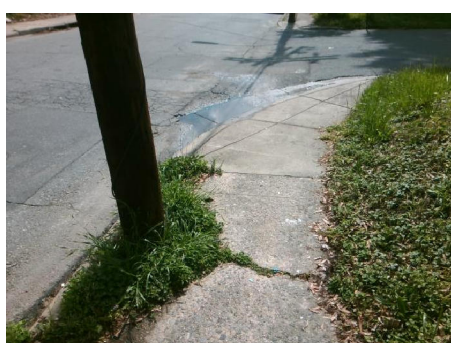
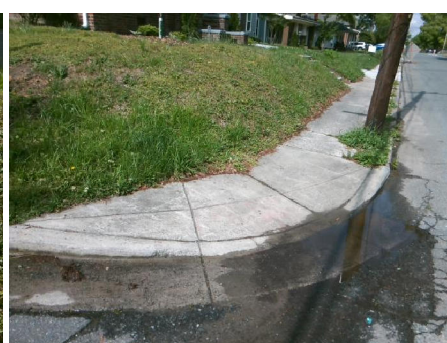
**Not Found, R304.5.1, R304.2.2, R304.5.3**

Compliance	Description	Data	Compliance	Description	Data
N/A	Ramp Length (in)	42.0	No	Ramp Slope (%)	9.2
No	Ramp Width (in)	29.0	No	Ramp XSlope (%)	4.8
N/A	Flare Type LT	N/A	N/A	Flare Type RT	N/A
N/A	Flare Slope LT (%)	N/A	N/A	Flare Slope RT (%)	N/A
N/A	Flare Traversable LT?	N/A	N/A	Flare Traversable RT?	N/A
N/A	Landing Length (in)	N/A	N/A	DWS Provided?	N/A
N/A	Landing Width (in)	N/A	N/A	DWS Contrast?	N/A
N/A	Landing Slope (%)	N/A	N/A	DWS Length (in)	N/A
N/A	Landing X Slope (%)	N/A	N/A	DWS Full Width?	N/A
N/A	Landing Curb? (Y/N)	N/A	N/A	DWS Offset (in)	N/A
N/A	Shared Landing?	N/A			
N/A	Gutter Ponding?	Yes	N/A	Gutter Slope (%)	N/A
N/A	Gutter Lip Ht (in)	N/A	N/A	Gutter X Slope (%)	N/A
N/A	Painted X Walk1?	No	N/A	Painted X Walk2?	N/A
	X Walk 1 Direction	To E		X Walk 2 Direction	N/A
N/A	X Walk 1 Width (in)	N/A	N/A	X Walk 2 Width (in)	N/A
	X Walk 1 Slope (%)	0.7		X Walk 2 Slope (%)	N/A
	X Walk 1 X Slope (%)	2.9		X Walk 2 X Slope (%)	N/A

N/A	Ramp inside XWalk1?	N/A	N/A	Ramp inside XWalk2?	N/A
	Road Slope (%)	N/A	N/A	Clear Space?	N/A
	Road X Slope (%)	N/A	N/A	Clear Space to XWalk (in)	N/A
N/A	Any Obstructions?	N/A	N/A	Storm Grate/Utility Hazard?	N/A
	Obstruction Type			Storm Grate/Utility Type	
		N/A			N/A
		Yes		Surface Condition? (G/P)	Good

**Remove & Replace Entire Ramp.**

Total Cost: \$ 1850.00
